Attachment 2

Existing Conditions – Quittapahilla Creek

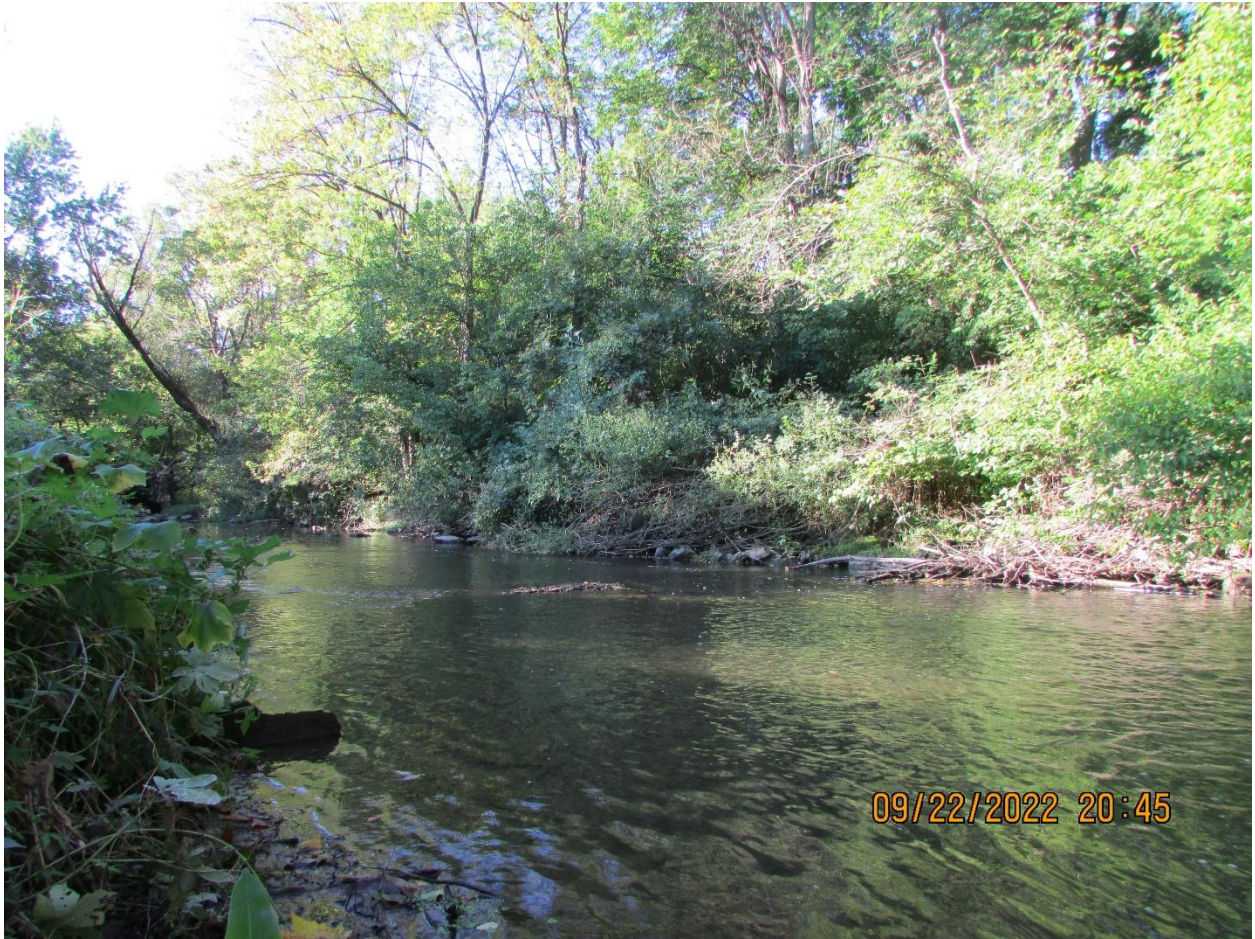
Picture showing shallow, poor habitat section of Quittapahilla Creek downstream from Spruce Street

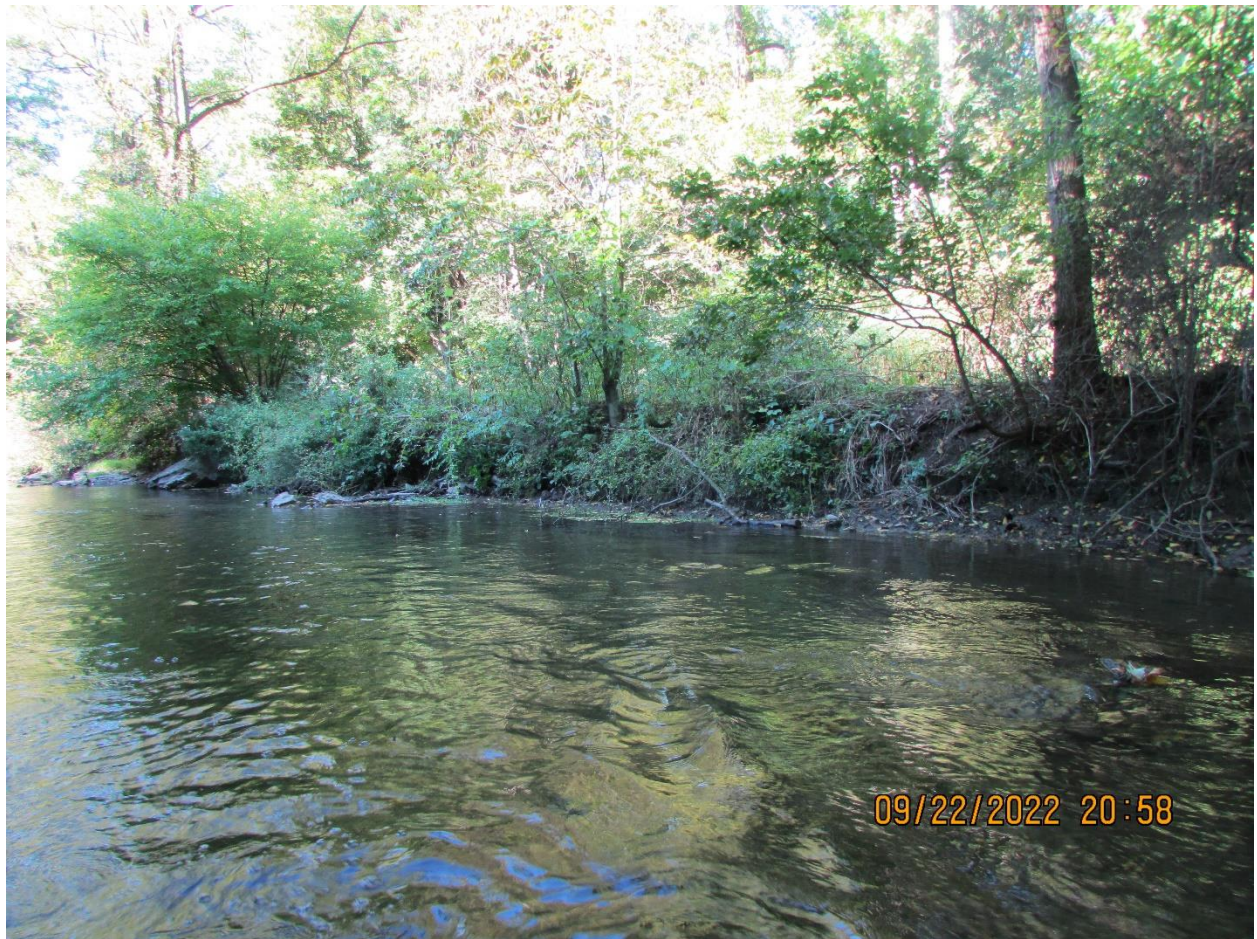
Picture showing steep, eroding bank in the Quittapahilla Creek downstream from Spruce Street

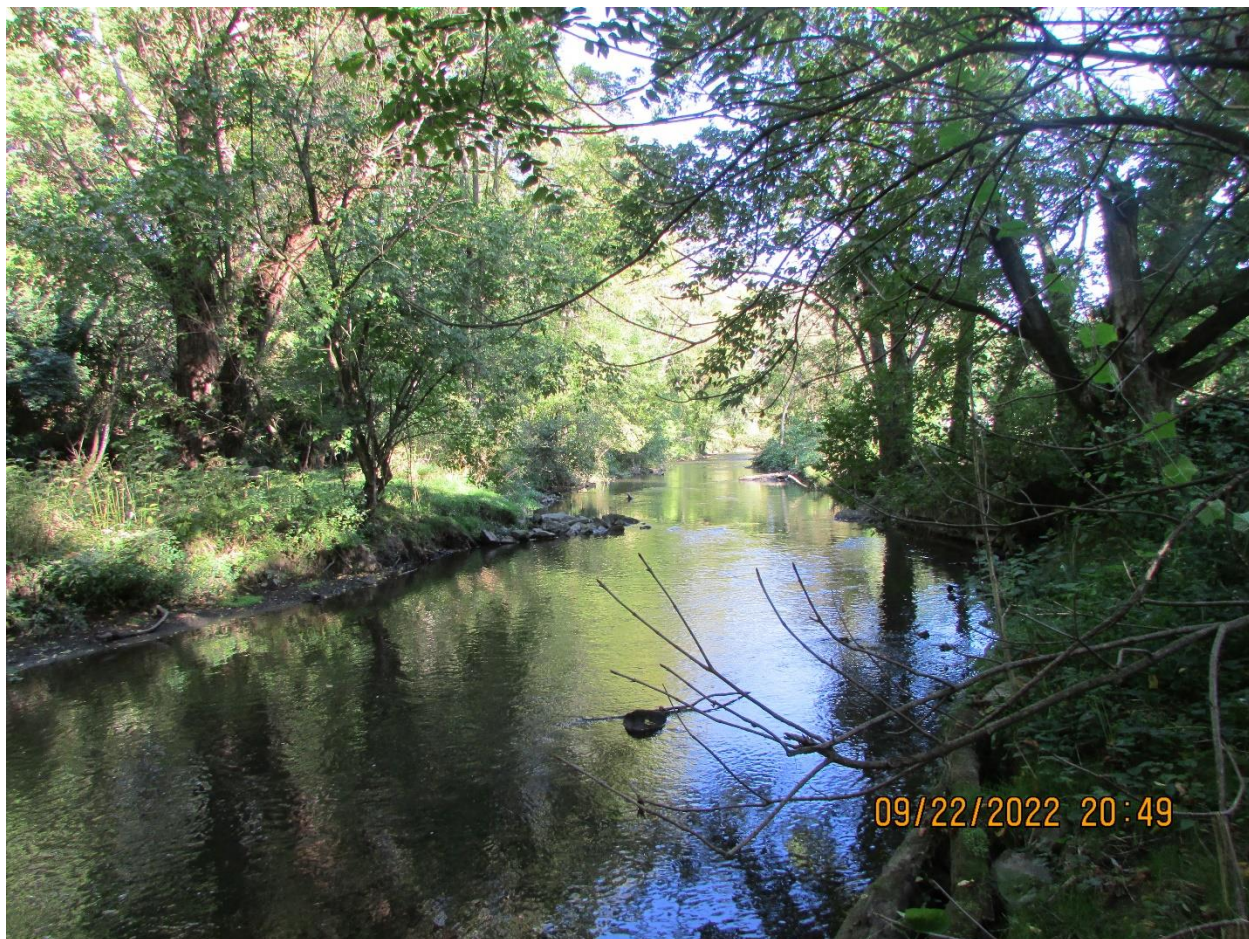
Picture showing low velocity, high sediment section of Quittapahilla Creek, downstream from Spruce Street.

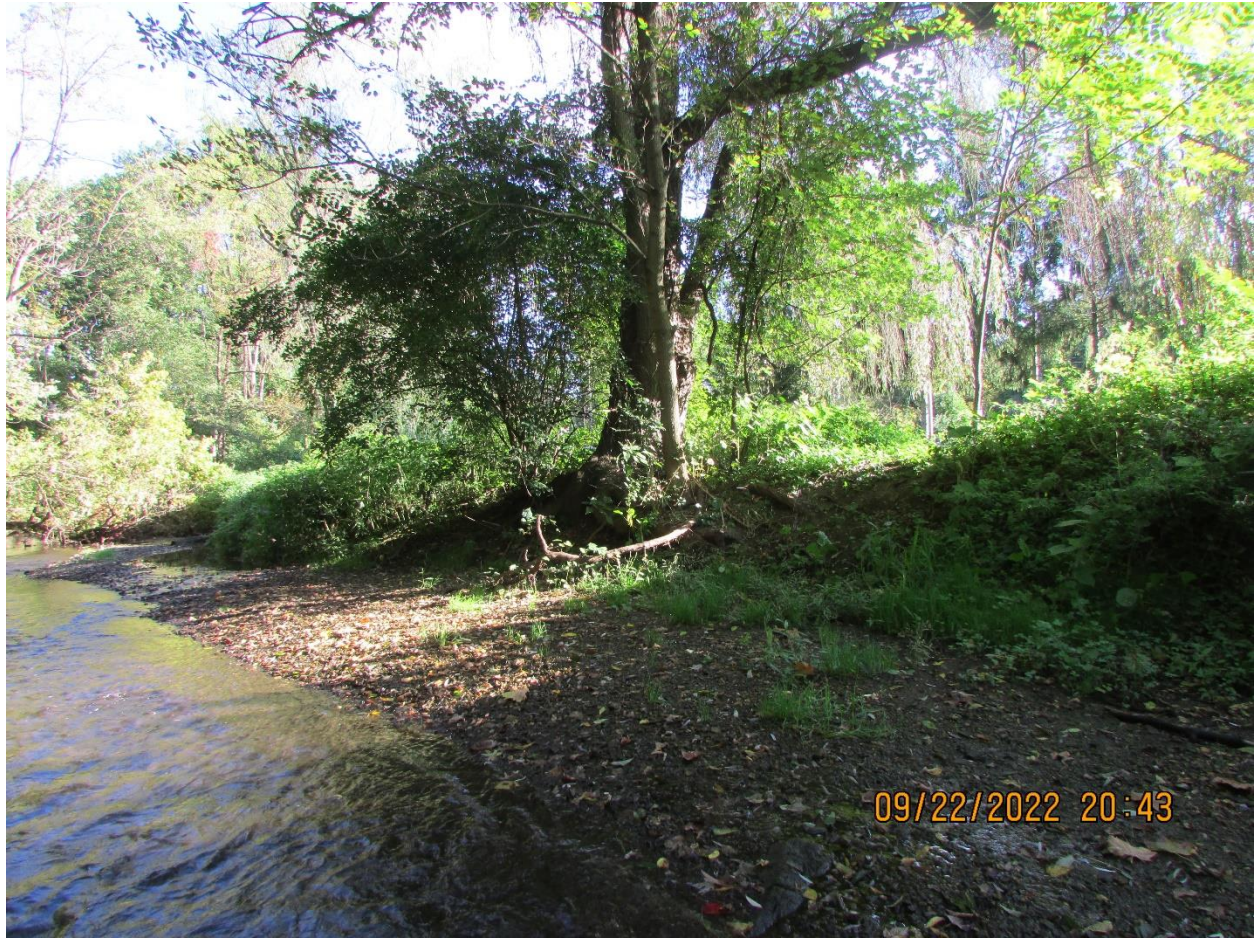
Picture showing extended gravel bar in Quittapahilla Creek, downstream from Spruce Street
