# Overview of Beck Creek and Bachman Run

HANNAH HORENGIC & BEN MITCHELL

# Overview of Project

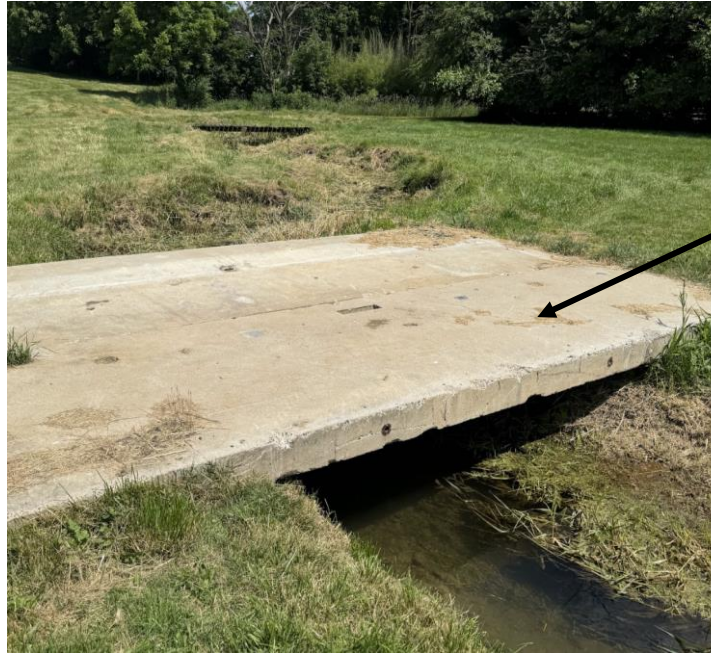
## Reach 13

- Narrow but deep section of stream in need of significant maintenance
- Renters note landlord drives heavy machinery along stream; tire ruts found along bank
- Grass cut very short with debris and sediment accumulating in stream
- Effects seen downstream

Concrete bridge and clear-cut banks

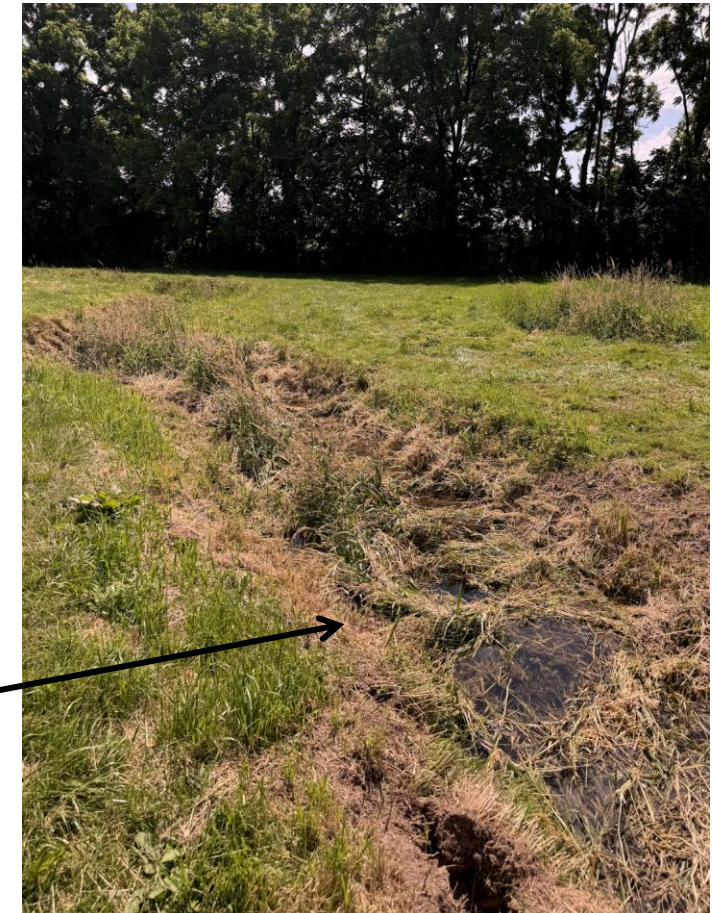
Extreme erosion (70%) serves as source of silt and debris

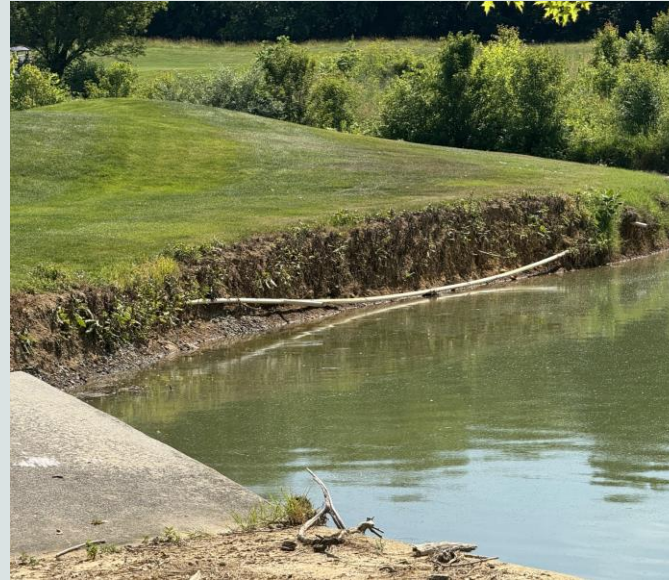
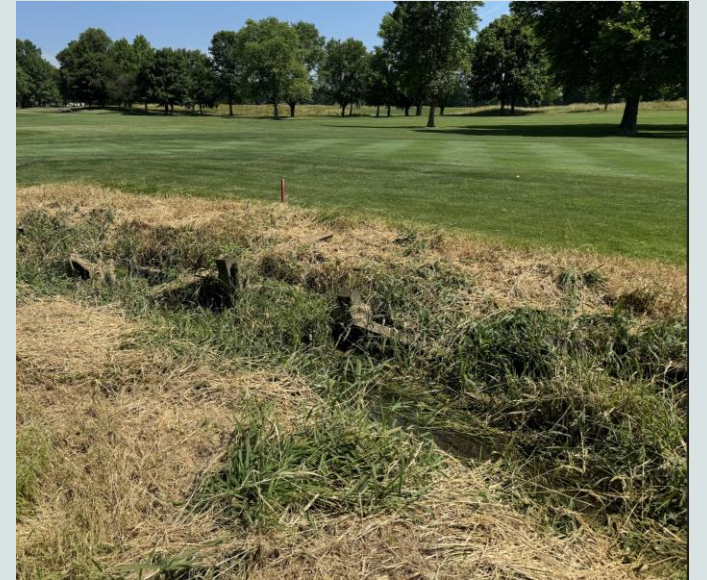
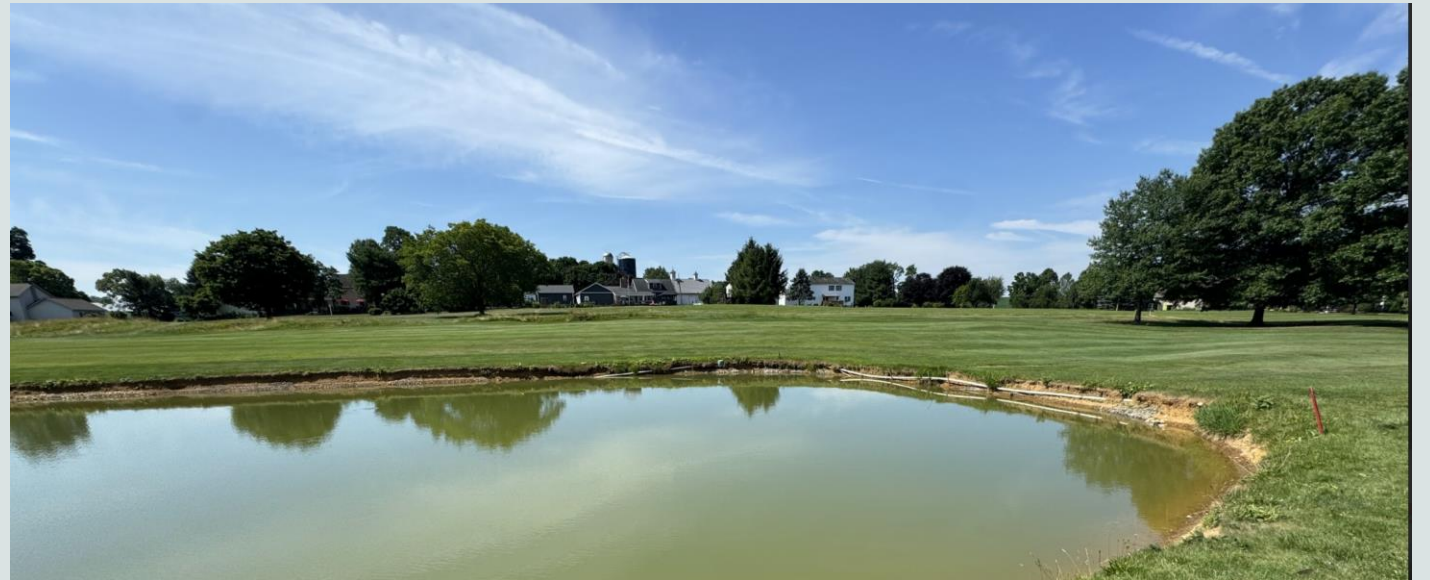
## Reach 19

- Man-made lake with exposed piping and sharp, exposed banks
- Periods of total drought
- Areas of clear-cut grass and subsequent moderate bank erosion
- Landowner suggested possibility of a dam upstream

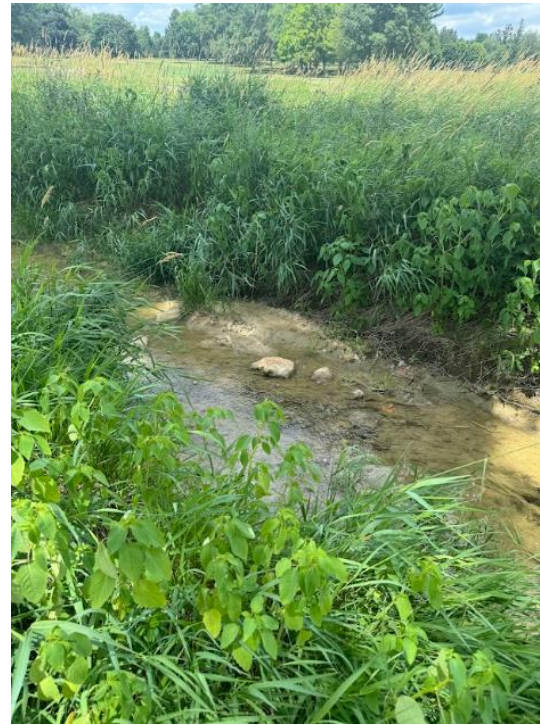
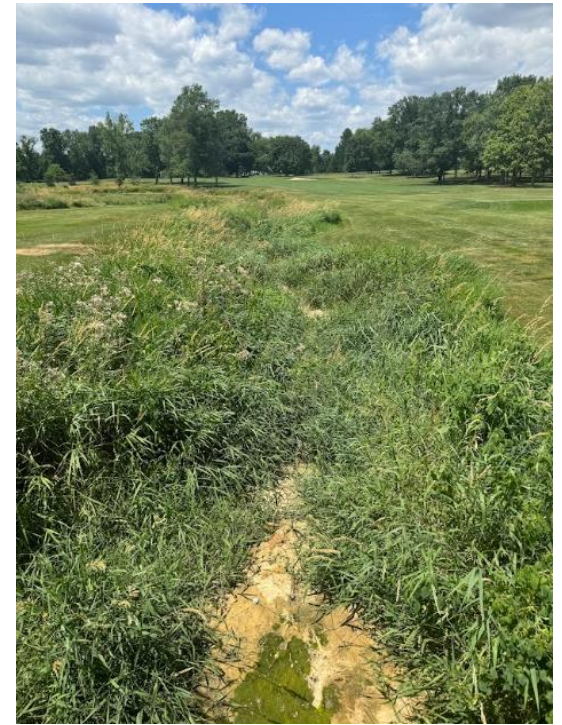
- Reach 20 loses flow for 1/3 of the reach.
- Reach 21 has several large freshwater springs that return flow to the stream.

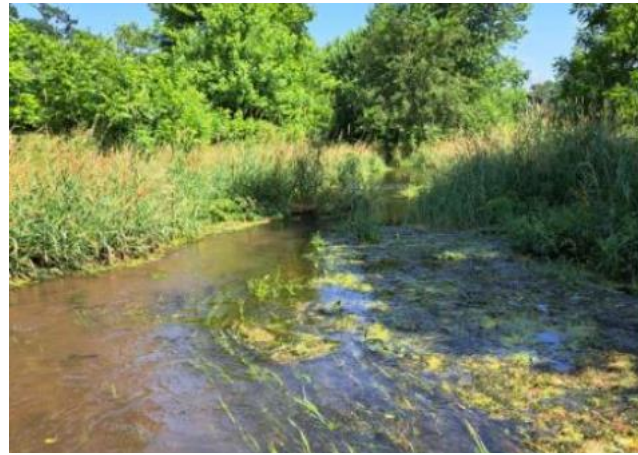
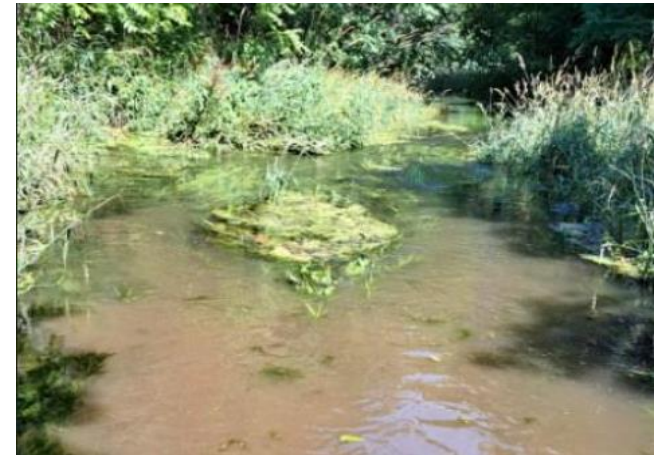
Reach 23

- Aggradation in channel
- Grass growing into channel
- Minimal buffer on reach 25

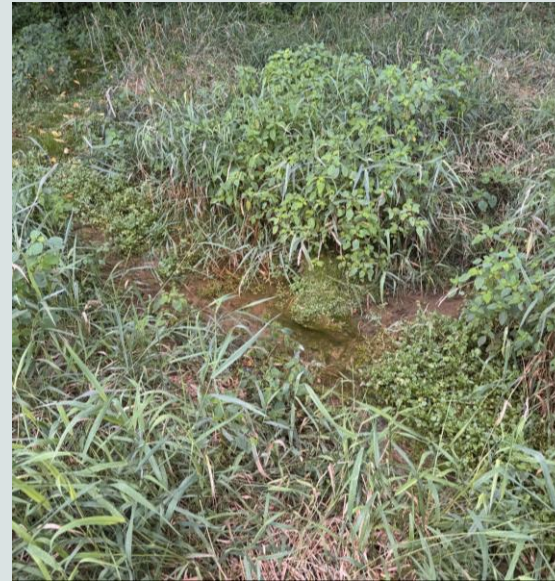
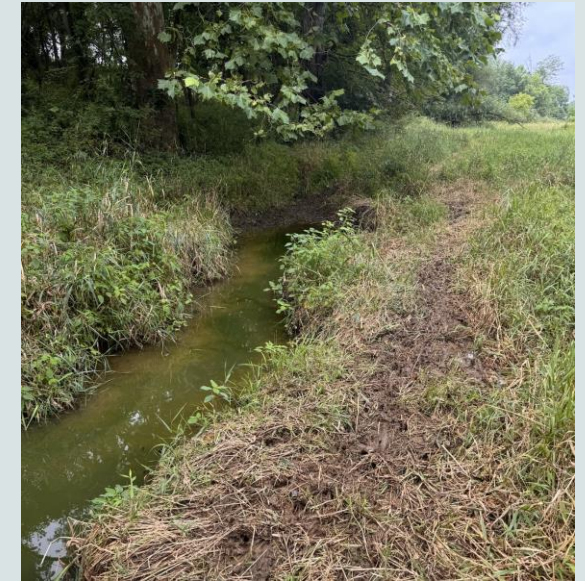
- Reach 1
  - Significant portion of dry streambed
  - Unshaded, grassy, and mown banks
- Reach 5
  - Drained lake; wetland-like and spring fed
  - Debris and runoff from cattle
  - Landowner concerned about stream and environment health over recent years

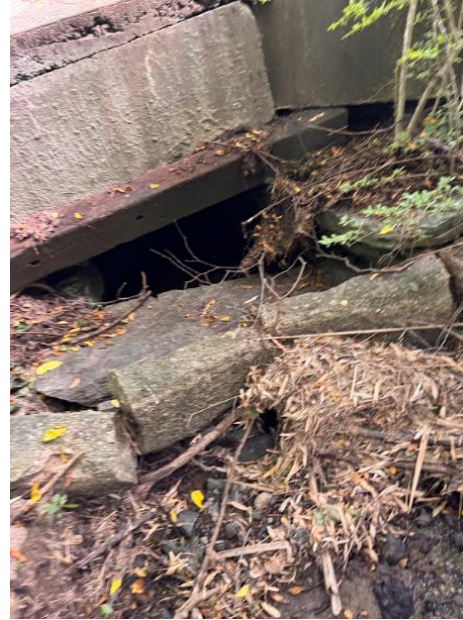
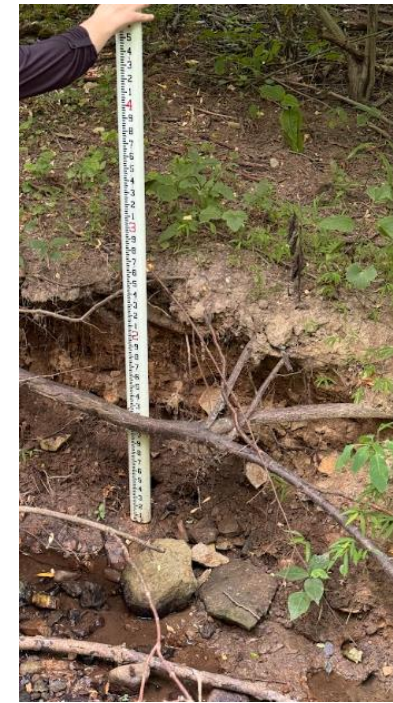
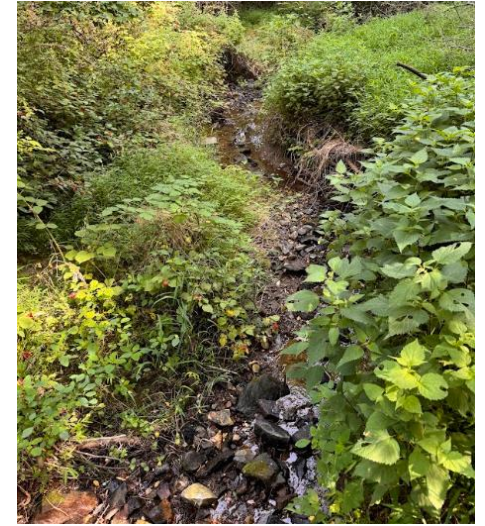
- Reach 1
  - Localized bank erosion
  - Blocked culvert
- Reach 3 & 4
  - No flow or low flow
- Reach 5
  - Flow returns
  - Some bank erosion towards the end of the reach

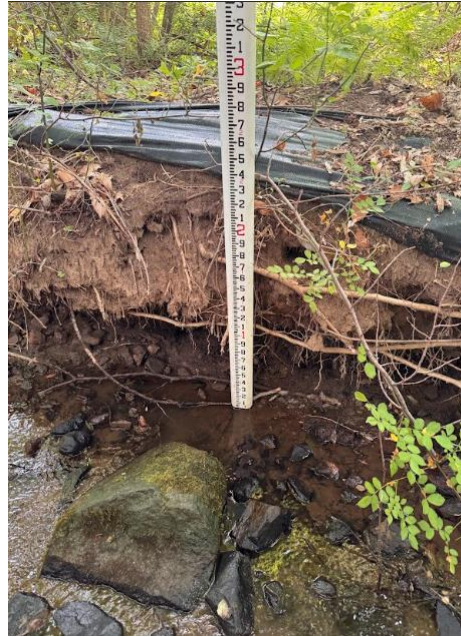
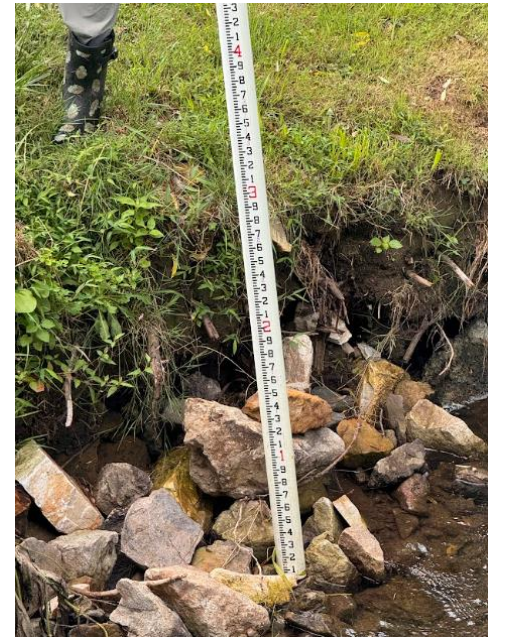
- Reach 1
  - Localized bank erosion
  - Undercut banks
- Reach 6
  - Small headcut
  - Bank erosion
  - Mowed up to bank

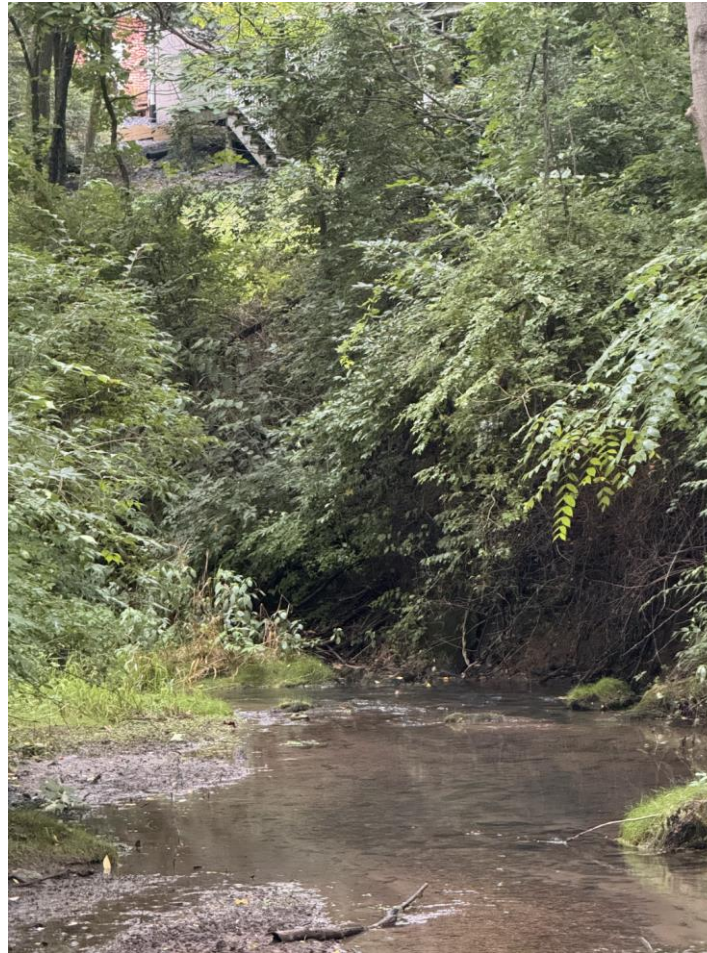
- Reach 2
  - Severe cliffside erosion threatening adjacent property
  - Trout hatcheries owned and operated by Fish & Wildlife
- Reach 3
  - Lengthy rip-rapped section with waterfalls that act as sediment filtration
