Site 5

Location: This site is located on the Lebanon Co-Tech School property immediately downstream of Metro Drive. The site is currently developed as a wetland with the Main Stem Quittapahilla running through the site. The site is bounded on the north by industrial, on the west by a prison and by the Vo-Tech school on the south. The wetland is directly adjacent to Route 422.

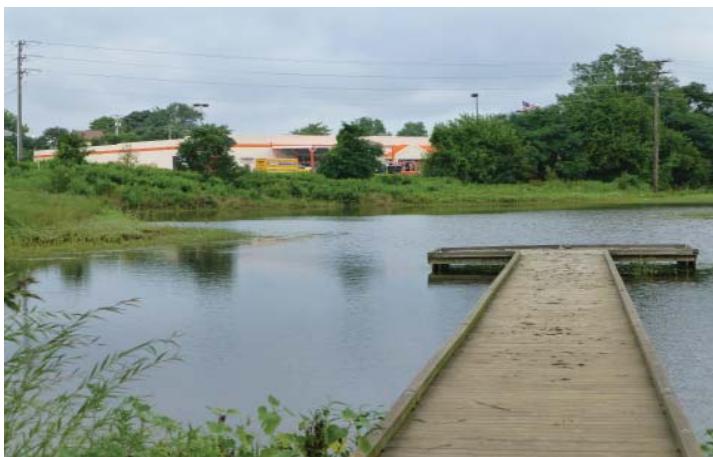
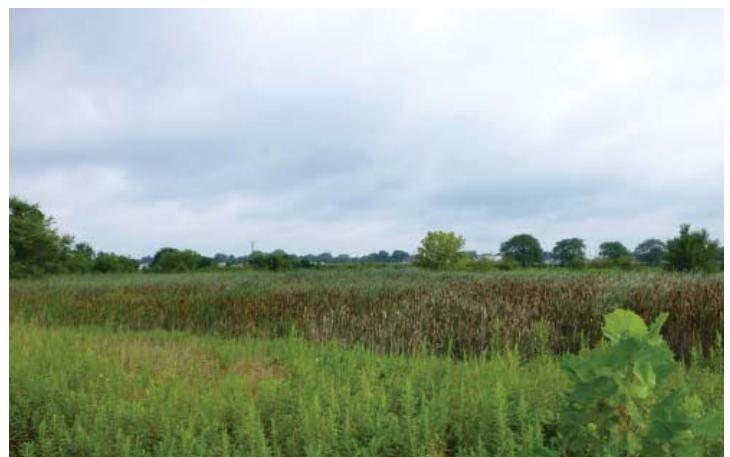
EXISTING

Description: The site is currently developed as a large functioning wetland-wildlife area. There is a pond, boardwalks, educational signs and wetlands. The site is handing stormwater inflows from the Vo-Tech school as well as from a rock-lined channel inputting stormwater from the industrial area. The wetland vegetation is dominated by cattails and lacks diversity. There are few trees. The Quittapahilla enters the wetland site under Metro Drive, form the southeast.

Potential: Wetland enhancements would greatly benefit this existing BMP. The wetland is well positioned to handle stormwater and improve water quality of the Quittapahilla prior to it flowing through the lined channel through the City of Lebanon. Wetland enhancement could include invasive species management, planting of more trees and upper-canopy species, expansion of the wetland and stream incorporation. The wetland could be expanded to the east towards Metro Drive. Native no-mow areas or meadows could be implemented to replace the mowed lawn on the southwest corner of the site near the pavilion. The currently stone-lined channel could be converted to a bioswale to convey the stormwater from the industrial areas to the wetland. A restoration could better incorporate the Quittapahilla into the wetland, creating greater sinuosity of the channel, increasing the number of wetland pockets and improving the riparian buffer along the stream.

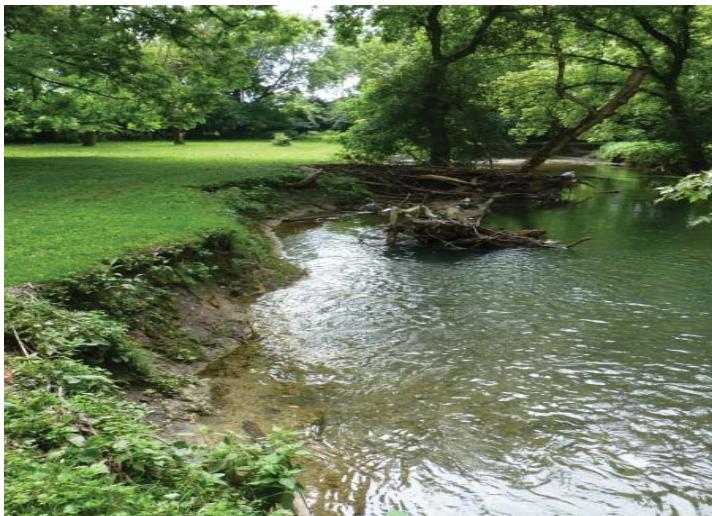
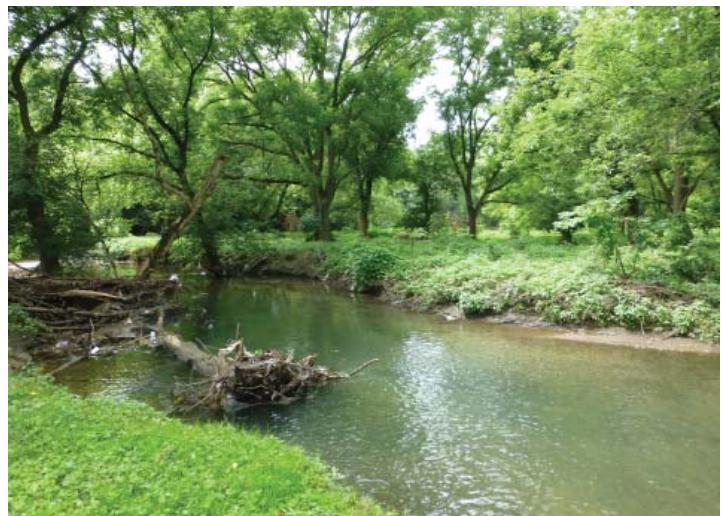
EXISTING

Description: The site is currently mowed floodplain with scattered trees. There is not a significant mature canopy along most of the reach. It is adjacent to a sloping agricultural field under cultivation. The Quittapahilla Creek is unstable throughout the entire reach, with steep, raw eroding banks. The banks are undercut and contributing significant amounts of sediment to the stream. The Chestnut Street Bridge is closed, with visible storm damage to the concrete bridge. There is debris accumulating on the wire fence that has been put in place to close the road, evidence of storm events that cause the stream to flow overtop the bridge. The streambed substrate is sediment-laden and lacking aquatic habitat.

Potential: The site would be very well suited for a complete floodplain restoration. A restoration would remove significant amounts of sediment that is being contributed to the Quittapahilla. Improvements could include restoration of the banks to their historic elevation through removal of legacy sediment and implementation of riparian buffers, wetland pockets, & in-stream habitat structures. A restoration would increase the flood storage on-site as well as potentially provide regional storage. Unlike site 2, this site does not already have a mature riparian buffer and canopy, which would make it a more qualified candidate for a restoration. The site is in a prime location, directly downhill of an agricultural field. Improvements could help to filter nutrient runoff from the field before entering the Quittapahilla. The site has demonstrated its need for restoration, evident from the road closure and bridge failure due to flooding.

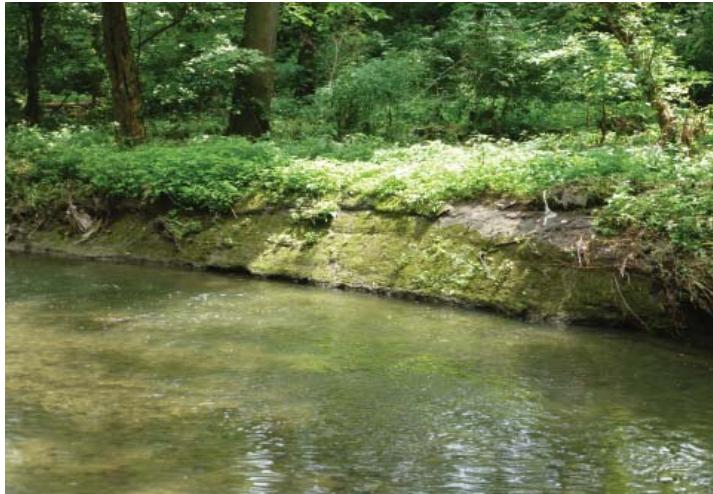
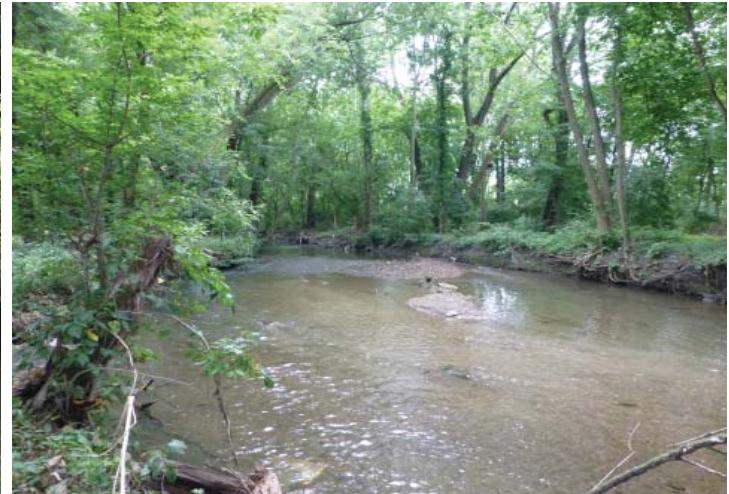
EXISTING

Description: The Quittapahilla Creek is very unstable throughout this reach. The reach is approximately 1,700' in length, flowing with minor sinuosity through mature canopy. The banks are steeply eroded, undercut and unvegetated, approximately 5' in height in most places. The sediment-laden floodplain is highly disconnected and the stream over widened through the entire reach. There are a few large debris jams as well as large gravel bars. One outfall empties into the Quittapahilla from Chestnut Street, and an identified stream enters from the north. The floodplains on both sides of the stream show signs of recent flooding.

Potential: The site would be very well suited for a complete floodplain restoration. The site is receiving multiple stormwater inflows which could be better managed and treated. The site has potential for a future trail system along this reach. A restoration would remove significant amounts of sediment that is being contributed to the Quittapahilla. A restoration would increase the flood storage on-site as well as potentially provide regional storage. Improvements could include restoration of the banks to their historic elevation through removal of legacy sediment and implementation of riparian buffers, wetland pockets, & in-stream habitat structures. A potential downside is that a mature, dense canopy already exists along the Quittapahilla throughout this reach which would have to be removed through a complete restoration.
