# Overview of Gingrich Run, Killinger Creek, and Snitz Creek

Hannah Horengic & Ilyssa Mclaughlin

# Overview of Project

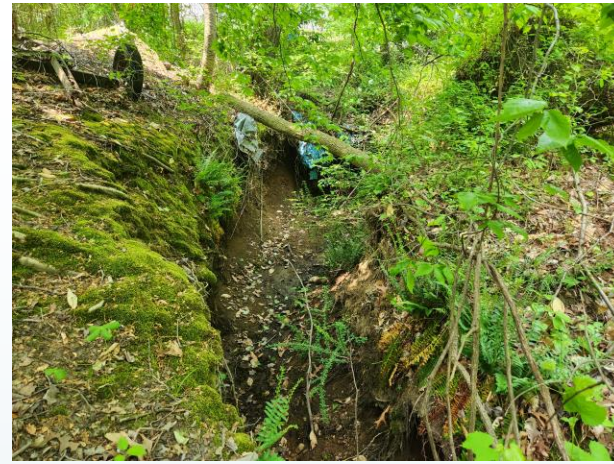
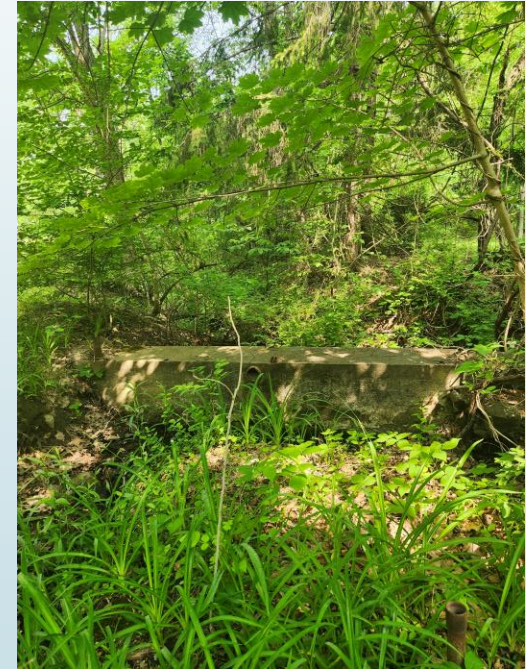
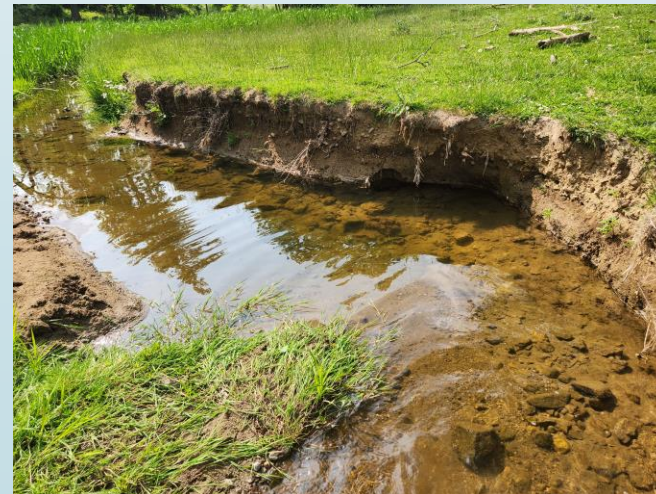
- ▶ Reach 1A
  - ▶ Extreme streambank and streambed erosion
    - ▶ Deep Gully Erosion
  - ▶ Breached concrete dam
- ▶ Reaches 2C,
  - ▶ Livestock access to creek
  - ▶ Bank erosion

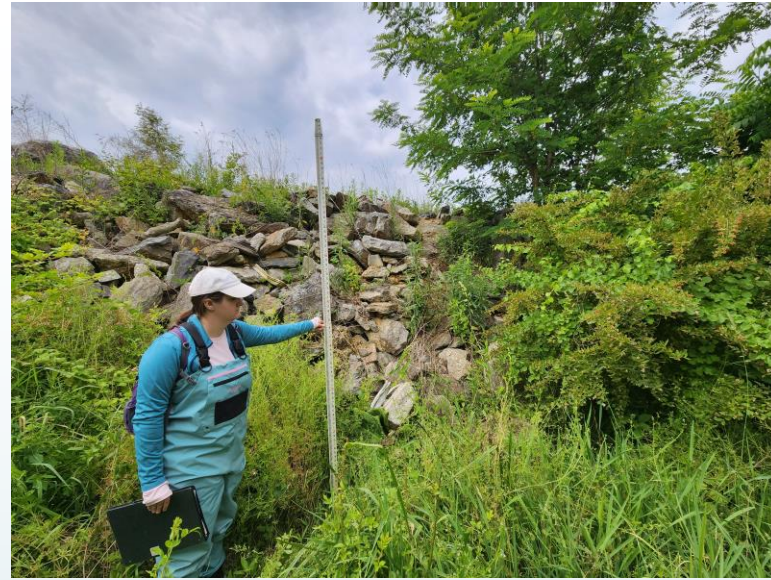
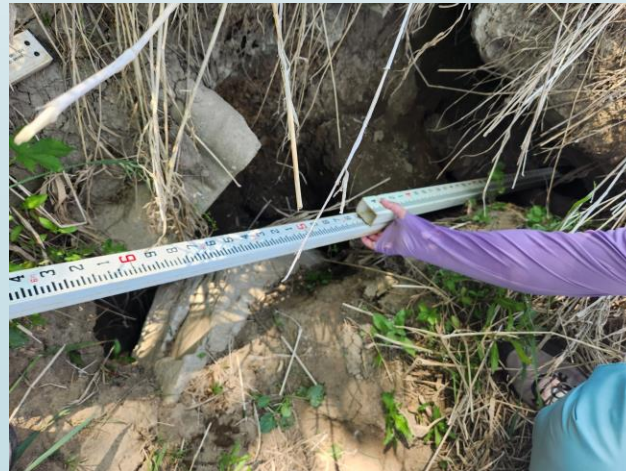
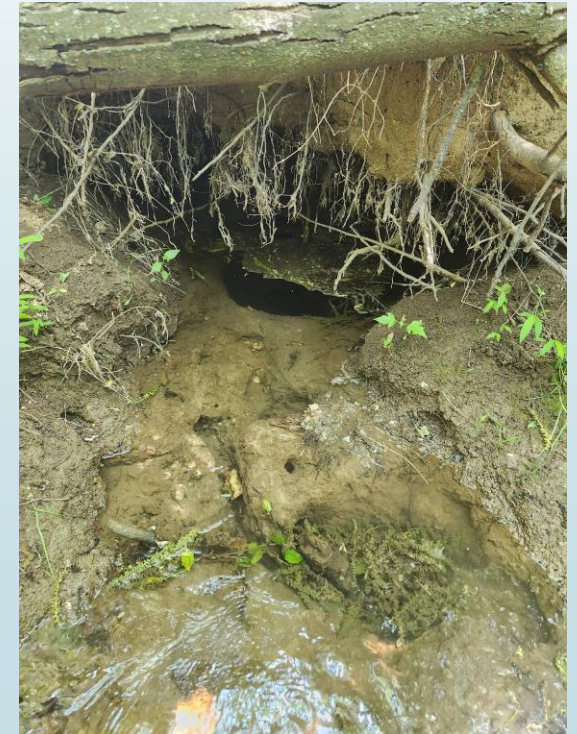
- ▶ Reach 2D
  - ▶ Earthen berms installed in 2017
  - ▶ Extreme bank erosion
  - ▶ Lateral & midchannel bars
- ▶ Reaches 5, 6, 7
  - ▶ No flow observed due to sinkholes
    - ▶ Locals concerned
  - ▶ Streambank Erosion

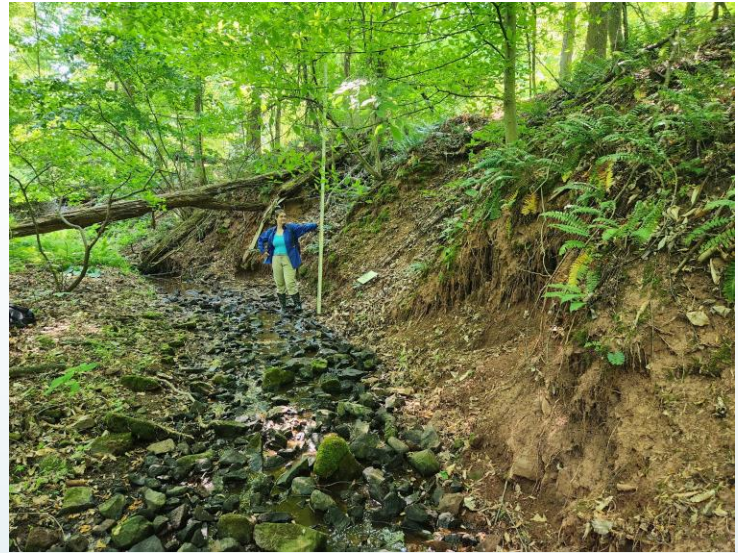
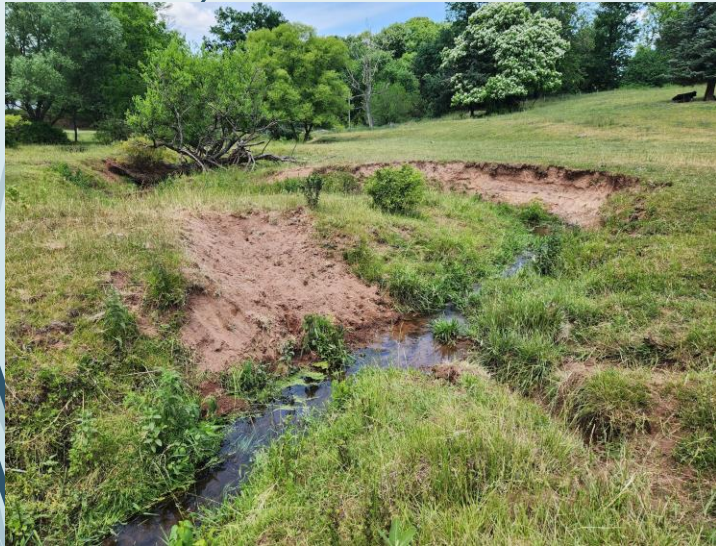
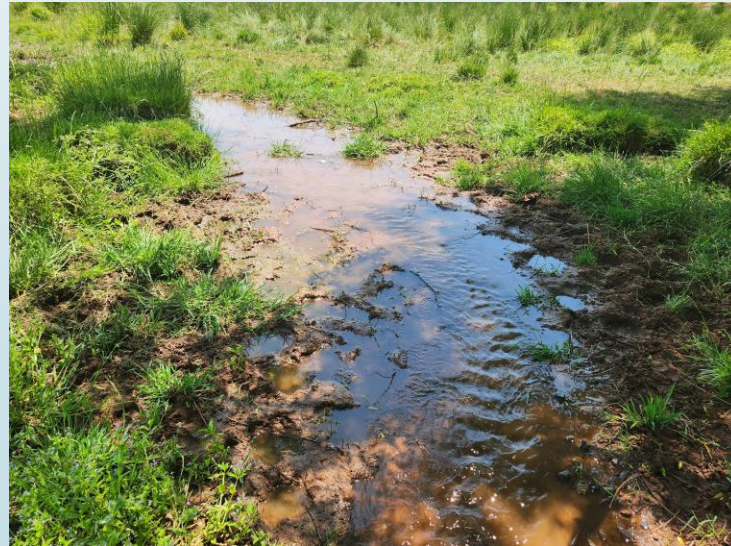
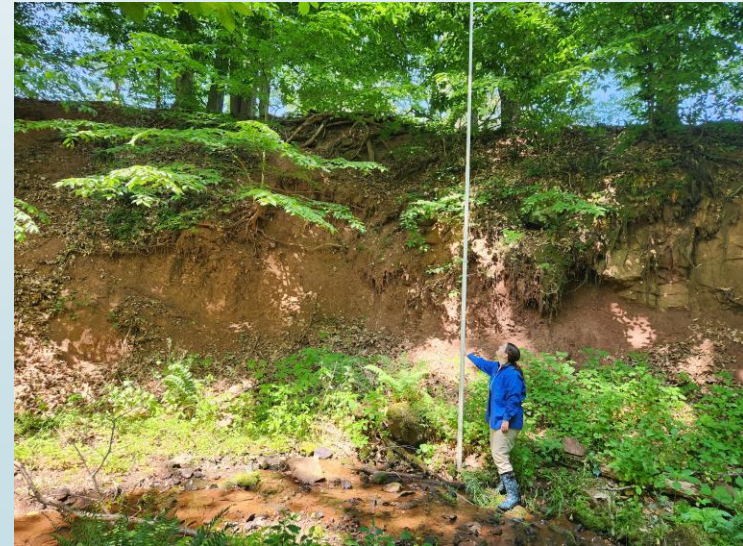
- Reach 1A
  - Extremely high bank heights on eroding banks on bends
  - Rest of stream in good condition
- Reach 1B, & 2C – Same Landowner
  - Cattle have access to creek

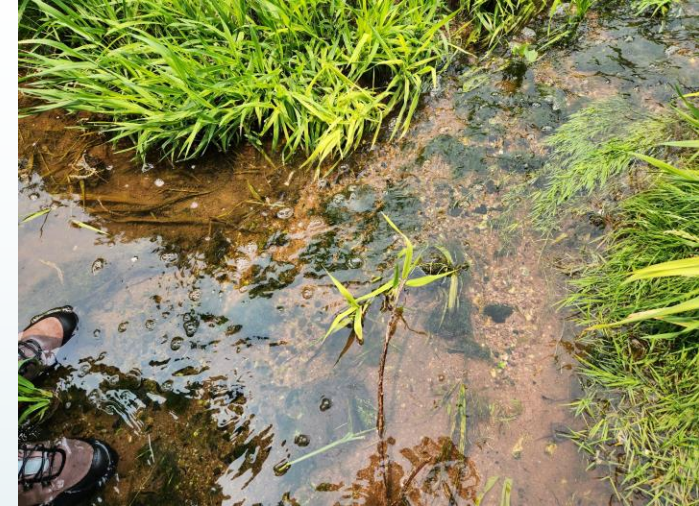
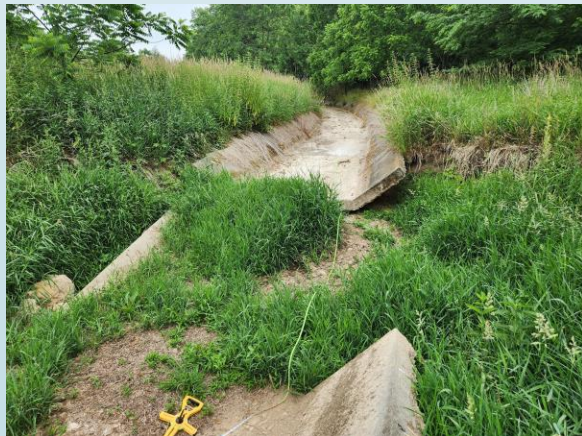
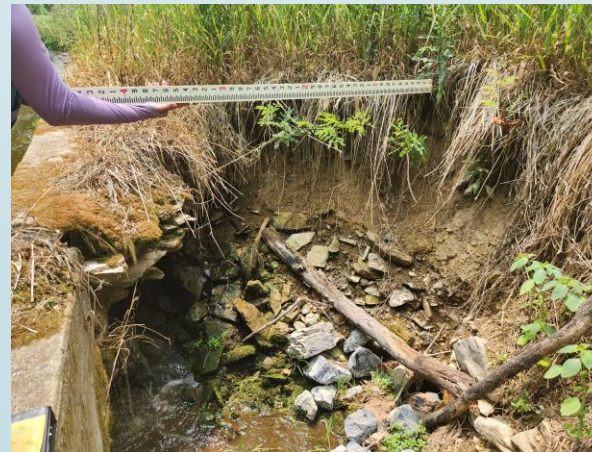
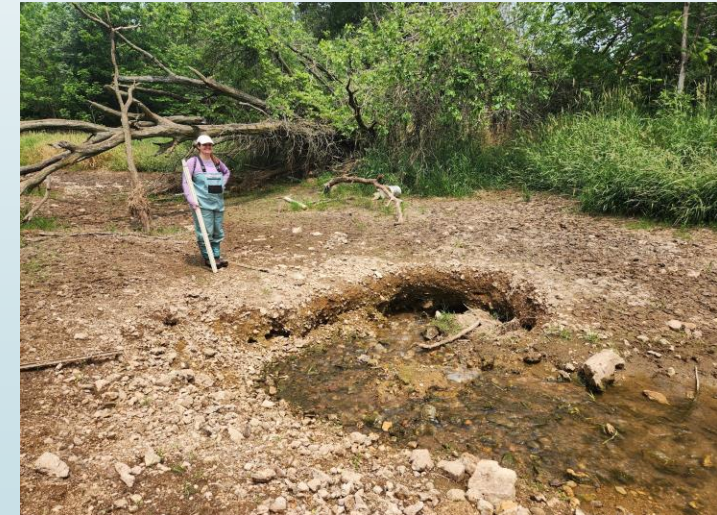
- ▶ Reach 4C
  - ▶ Township water treatment discharge went into creek
    - ▶ Smell of chlorine and bubbles were observed
- ▶ Reach 7B & 8
  - ▶ Concrete flumes with holes and broken sections
  - ▶ Large sinkhole that consumes stream

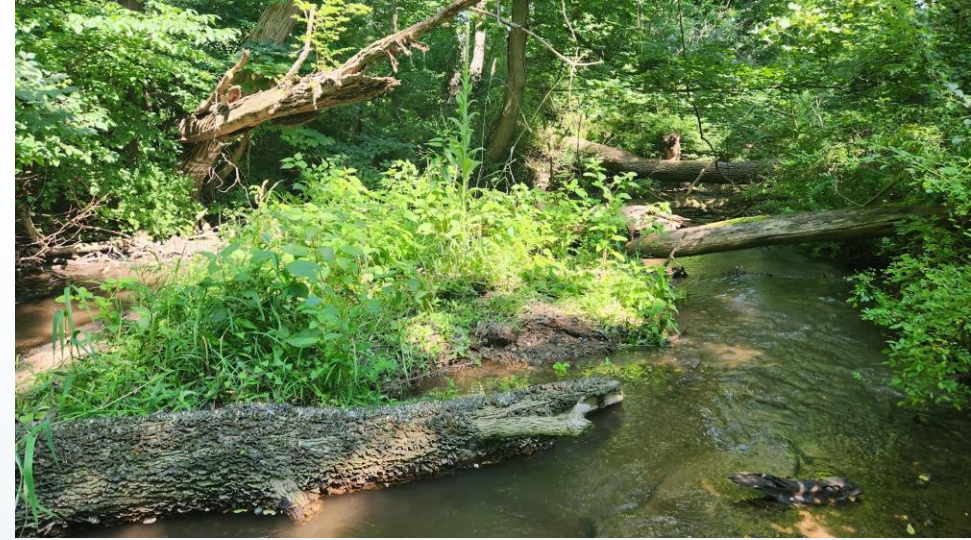
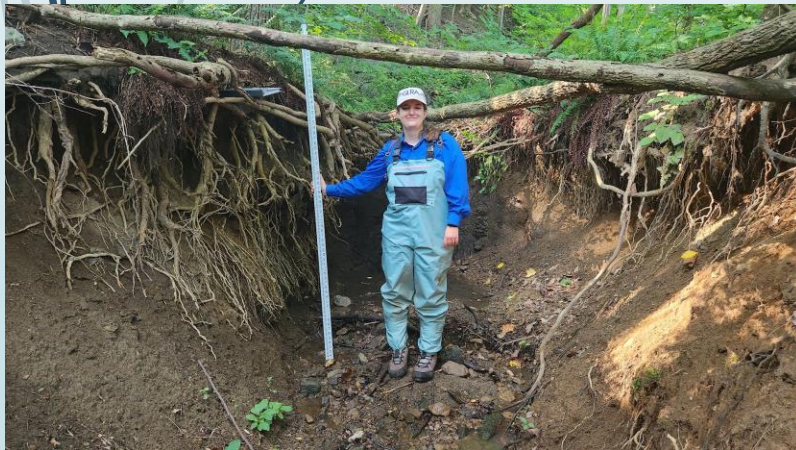
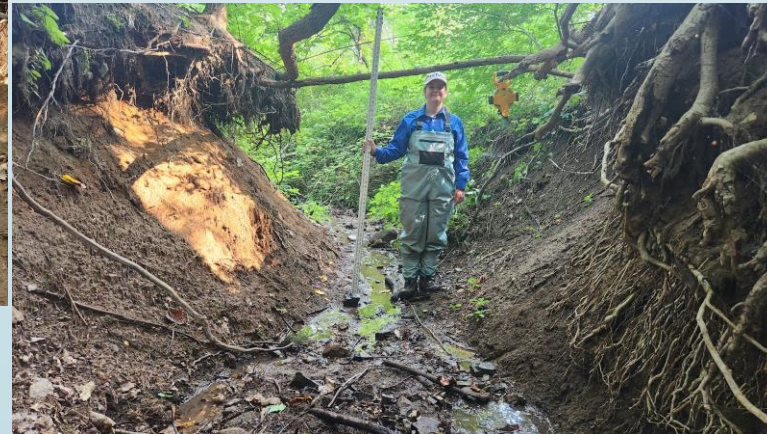
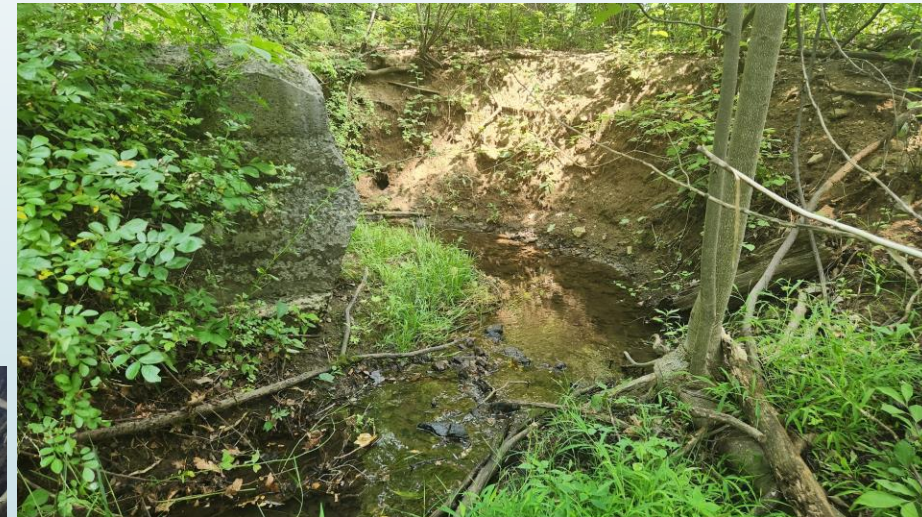
- Reach 7
  - Large, fallen trees blocking channel and causing diversions
  - Numerous jams and large mid-channel bars with eroding banks
- Reach 11A & 11B
  - Severe bank erosion with a failing dam and active headcuts

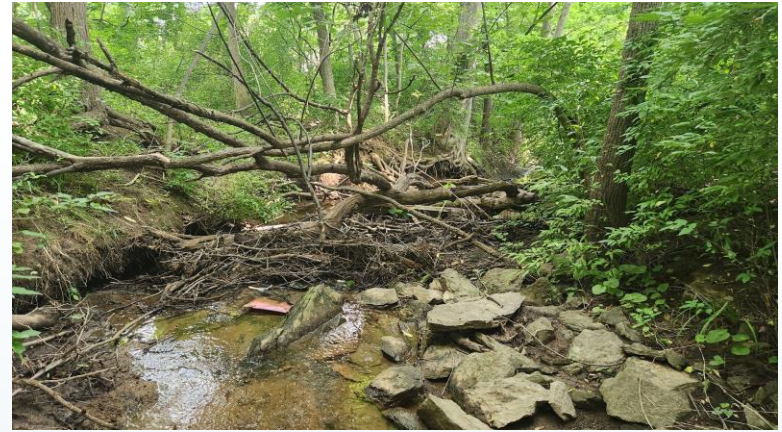
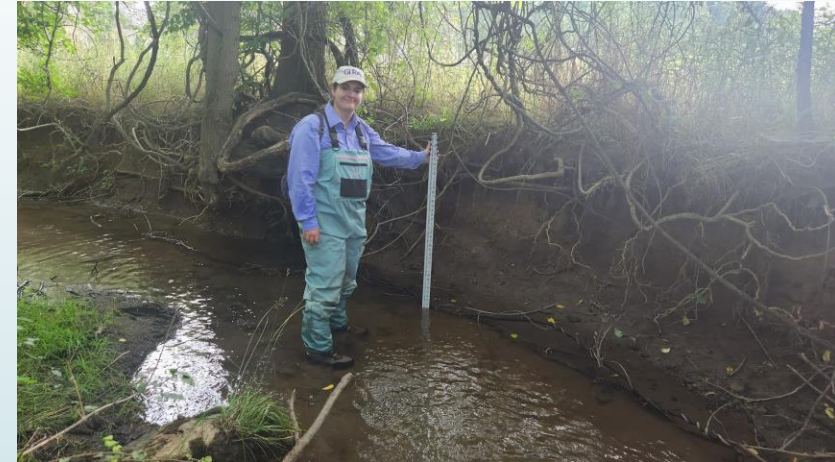
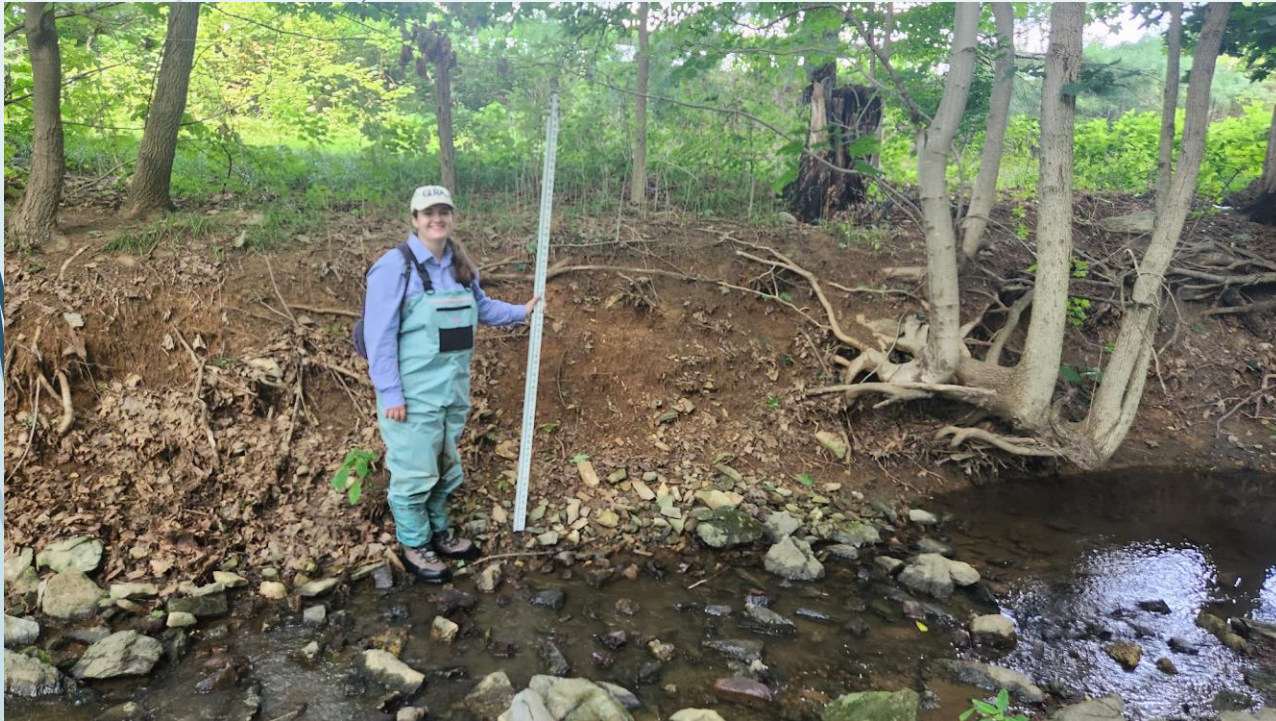
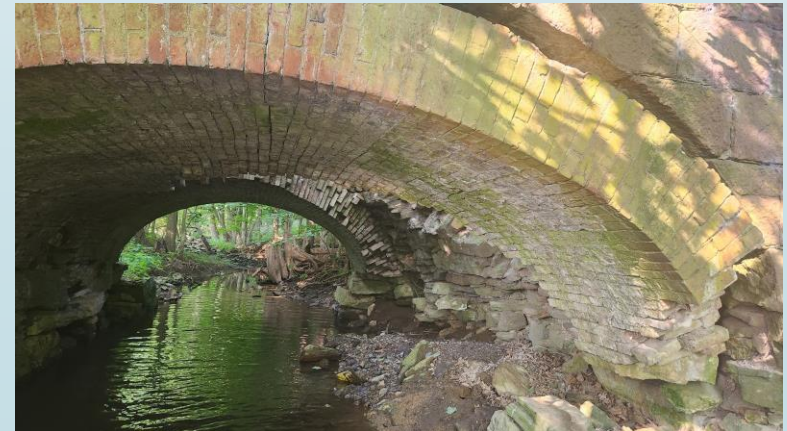
- ▶ Reaches 13B, 14, 15
  - ▶ Eroding banks along majority of these reaches
  - ▶ Frequent leaning and fallen trees creates blockages
  - ▶ Failing abandoned bridge collapsing into channel

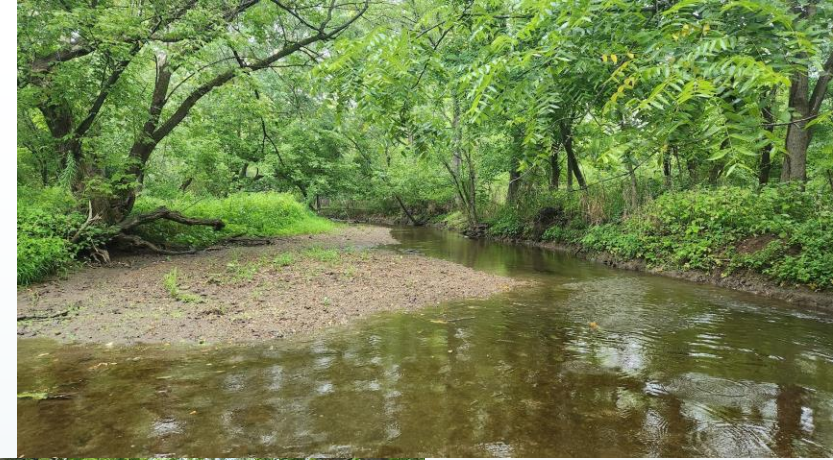
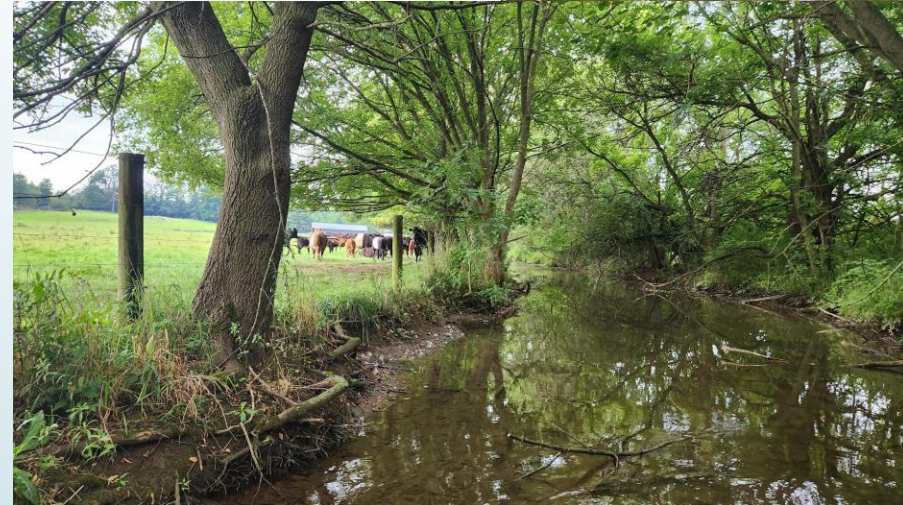
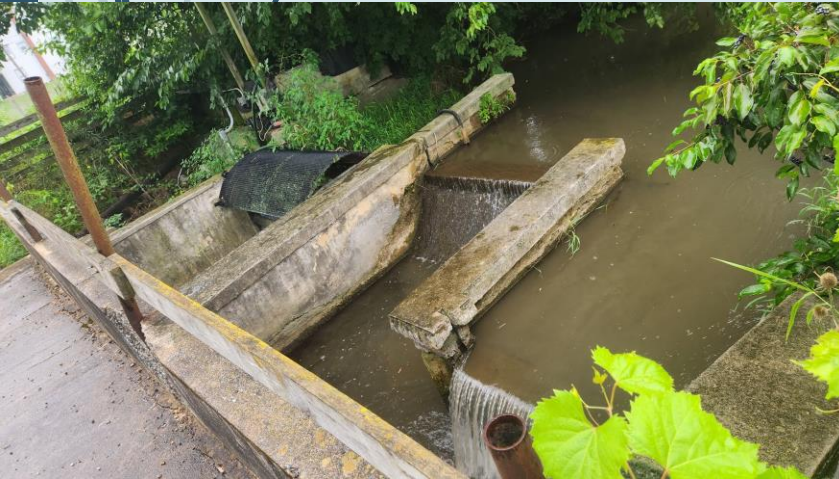
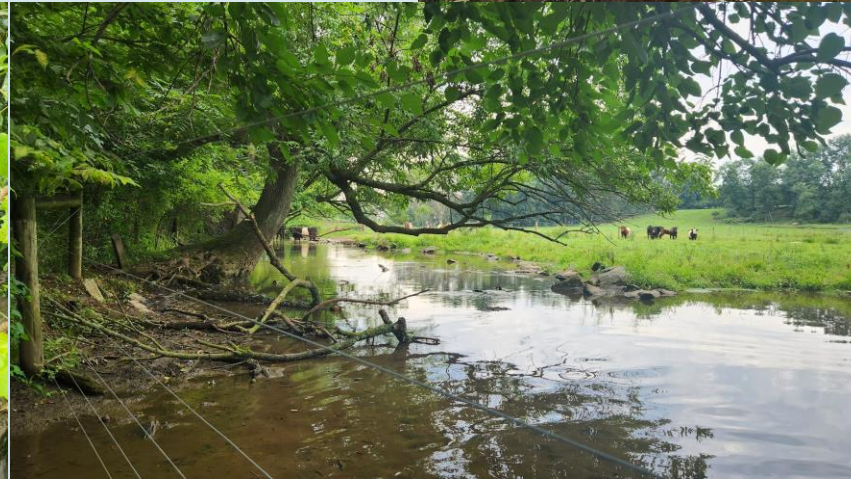
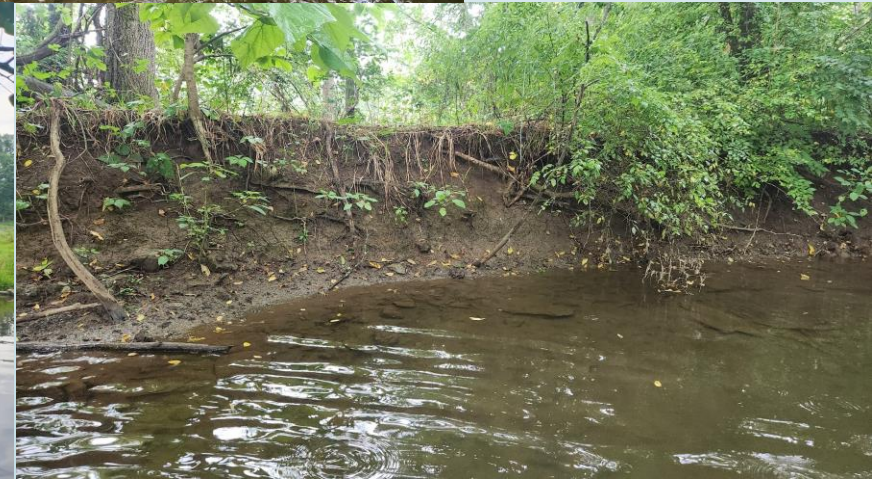
- ▶ Reaches 19-22
  - ▶ Unstable banks with erosion on 75-80% of each reach
  - ▶ Undercut banks
  - ▶ Dams, stonewalls and water withdraw structures
  - ▶ Livestock impacts
