**DESIGN REPORT  
FOR  
QUITTIE NATURE PARK  
STREAM RESTORATION PROJECT  
ANNVILLE TOWNSHIP,  
LEBANON COUNTY, PENNSYLVANIA**

**PREPARED FOR  
QUITTAPAHILLA WATERSHED ASSOCIATION**

**CLEAR CREEKS CONSULTING**

**May 2012**

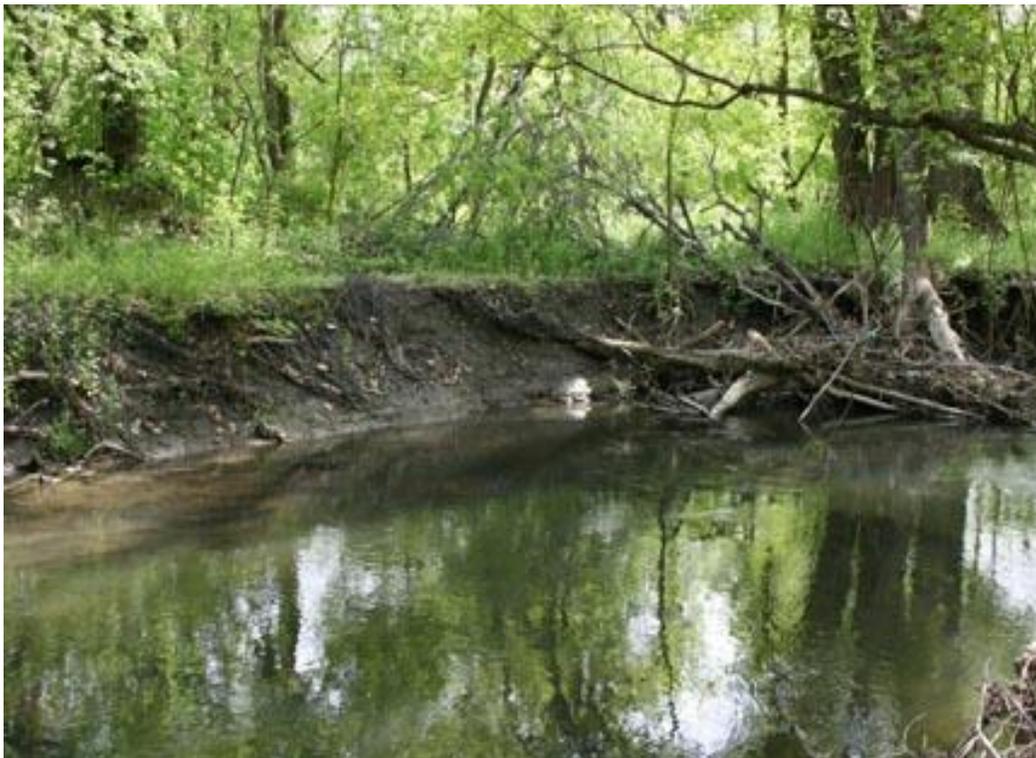
Eroding banks and debris jam in upper project reach

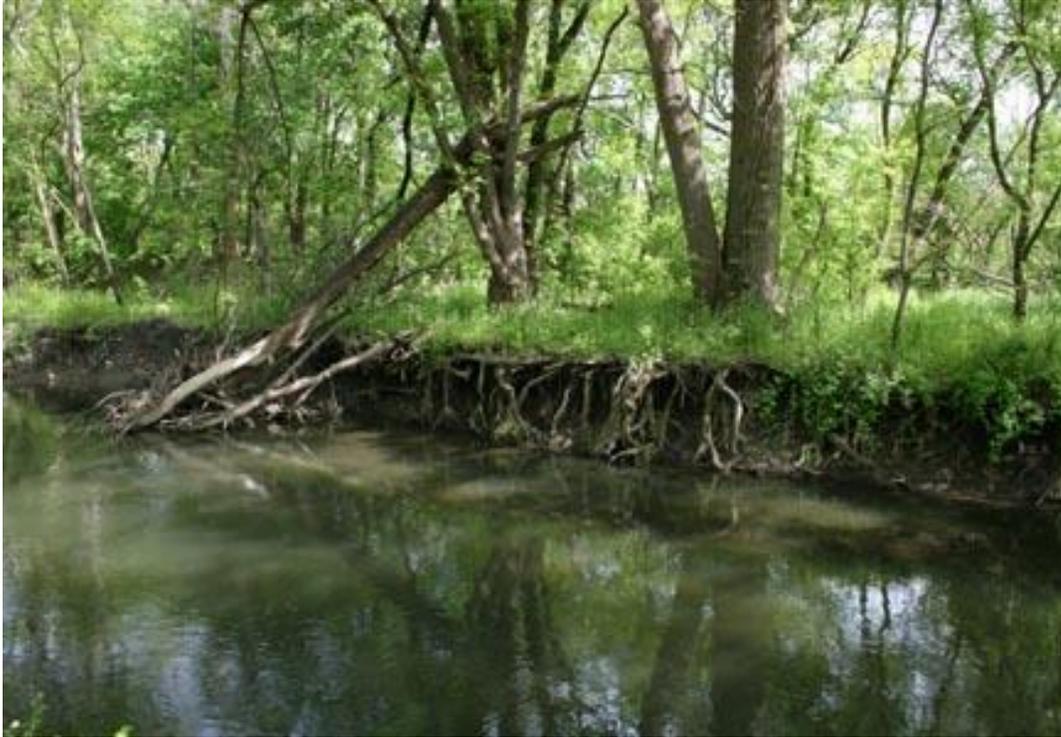
Eroding banks and debris jam in upper project reach

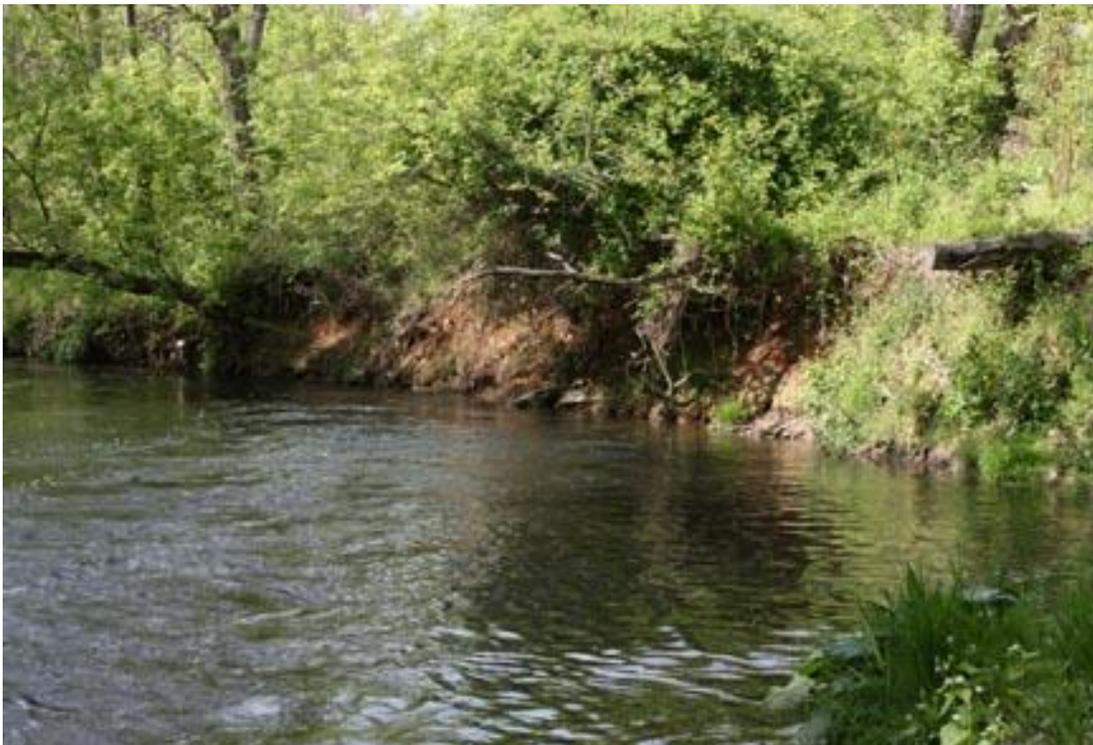
Eroding banks in middle project reach

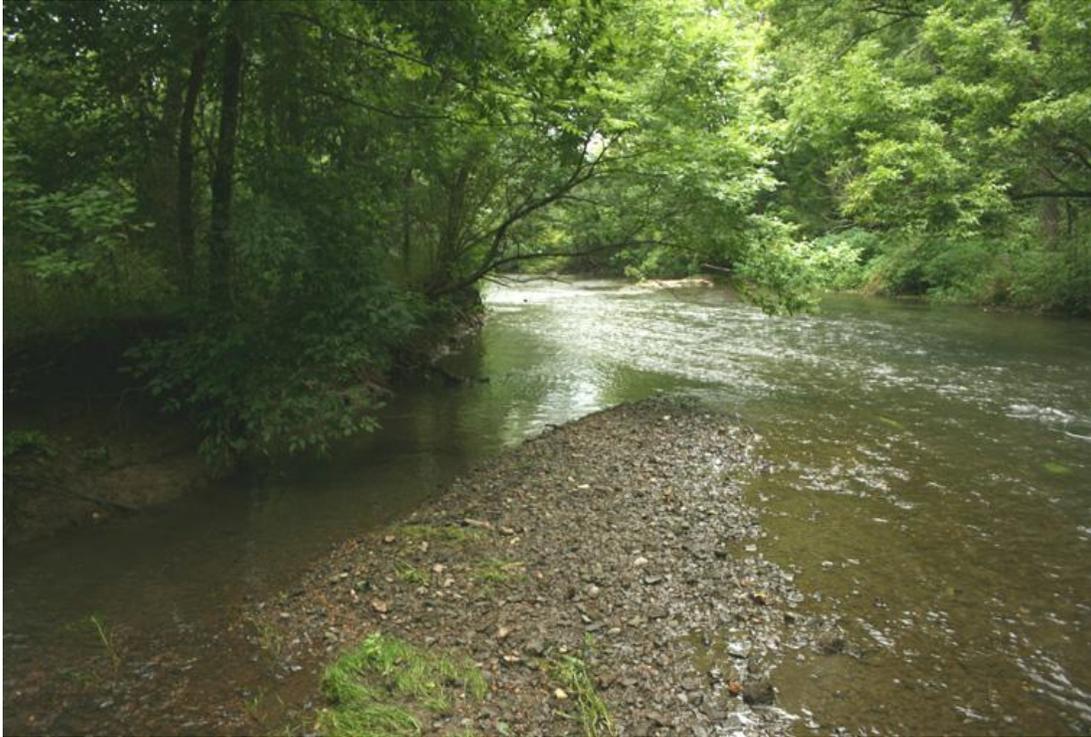
Lateral bar along middle project reach

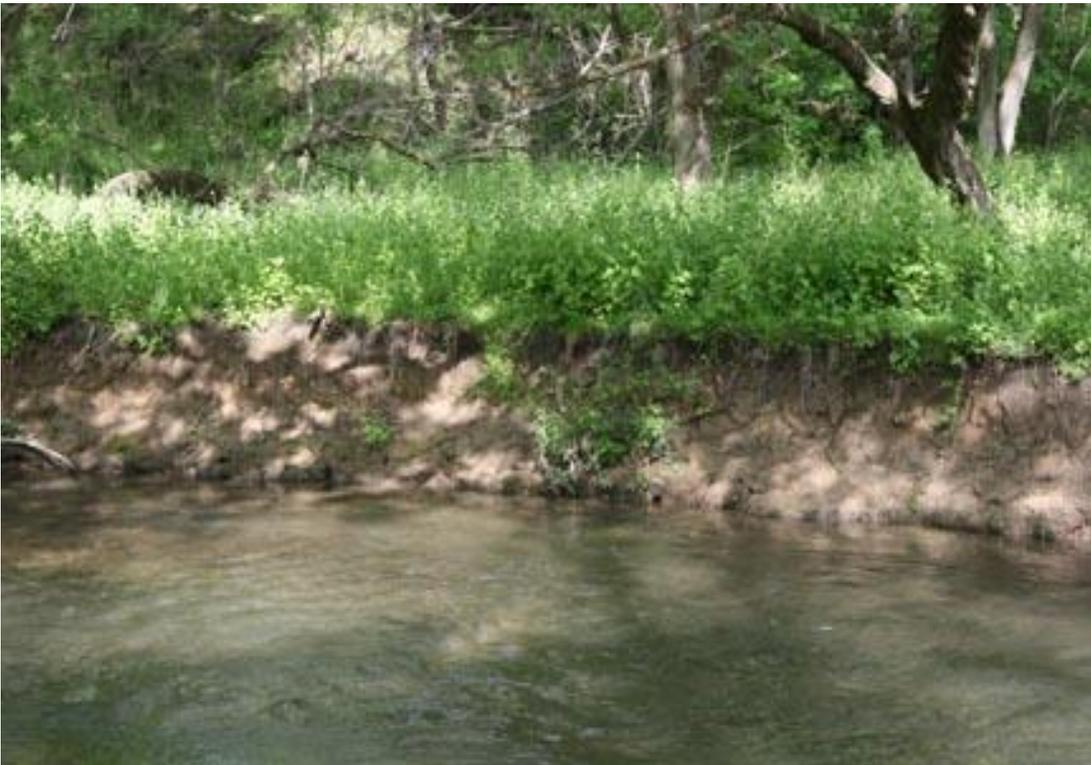
Eroding banks in middle project reach

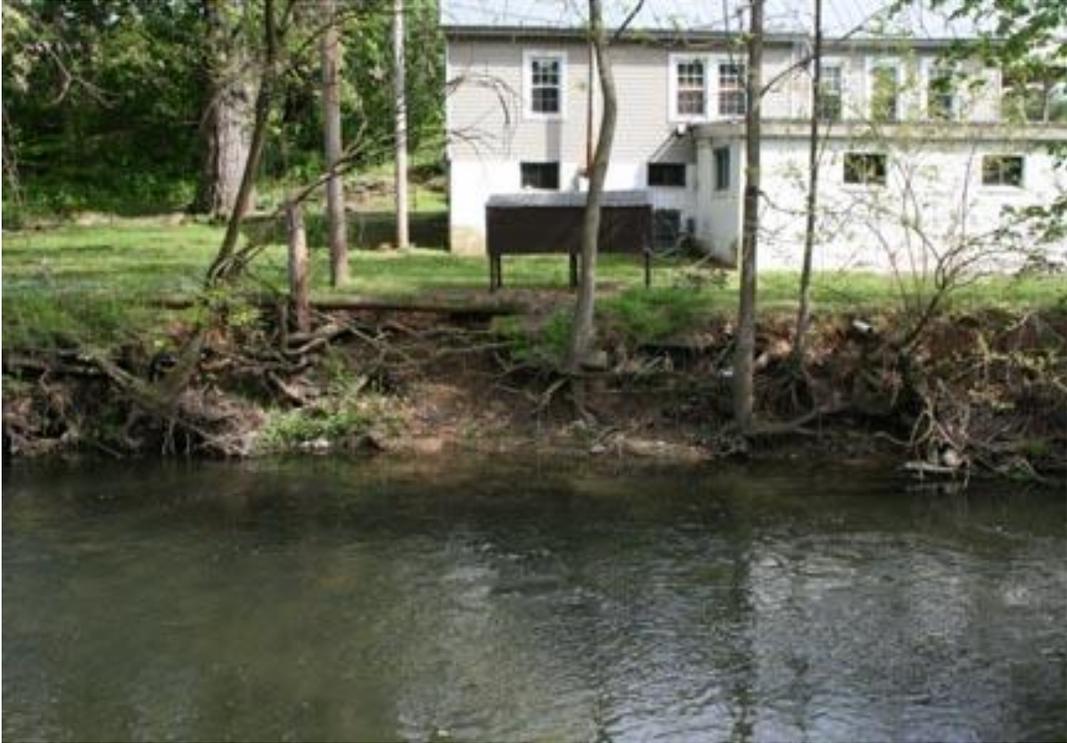
Eroding banks in lower project reach

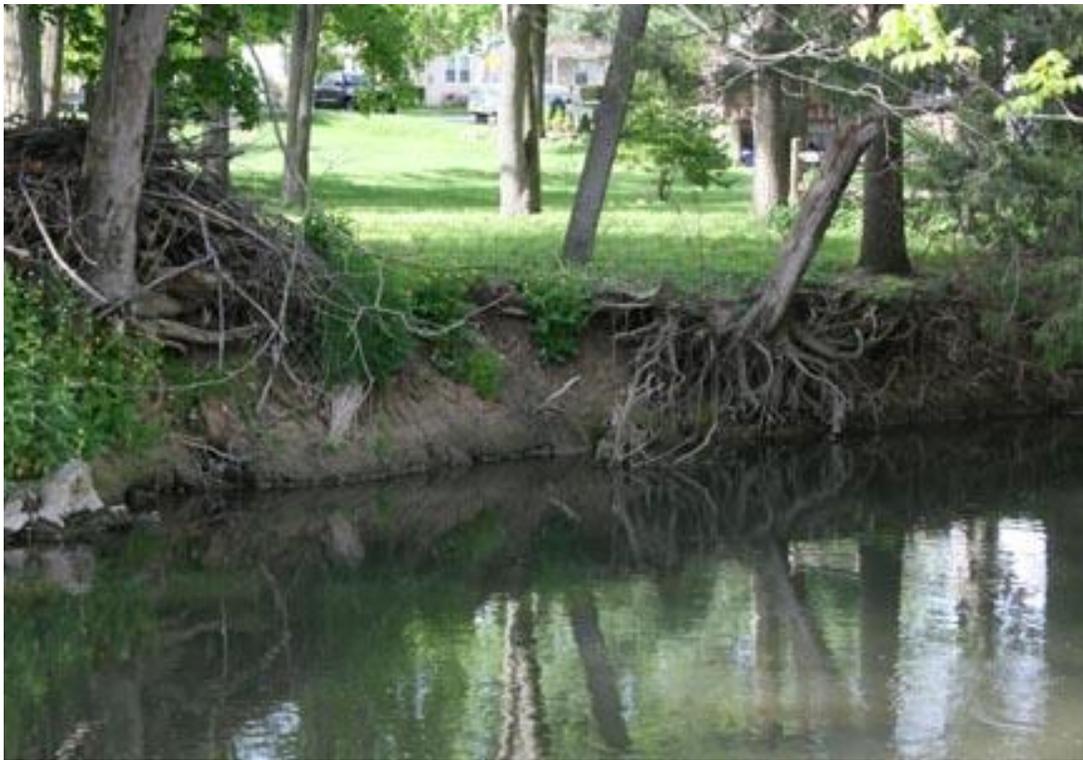
Eroding banks in lower project reach

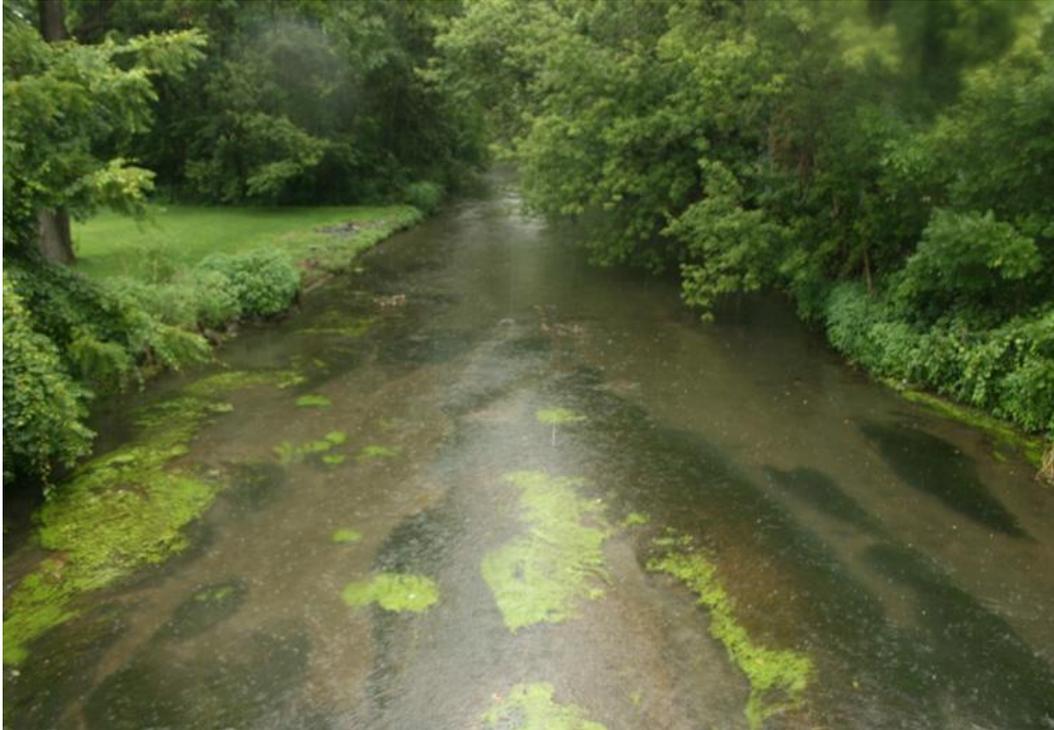
Over-wide channel with algal growth and heavy sedimentation at downstream end of project

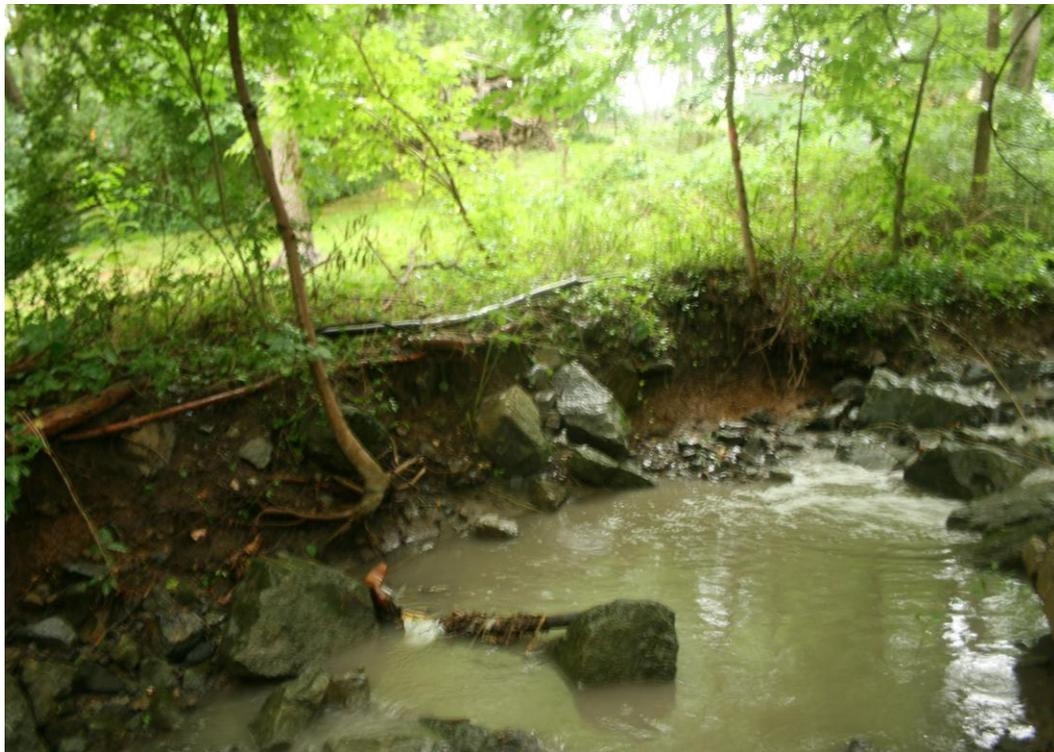
Bank erosion along tributary

- Grading and stabilizing the eroding streambanks

- Reconstructing the channel section to provide grade control by installing boulder step-pools

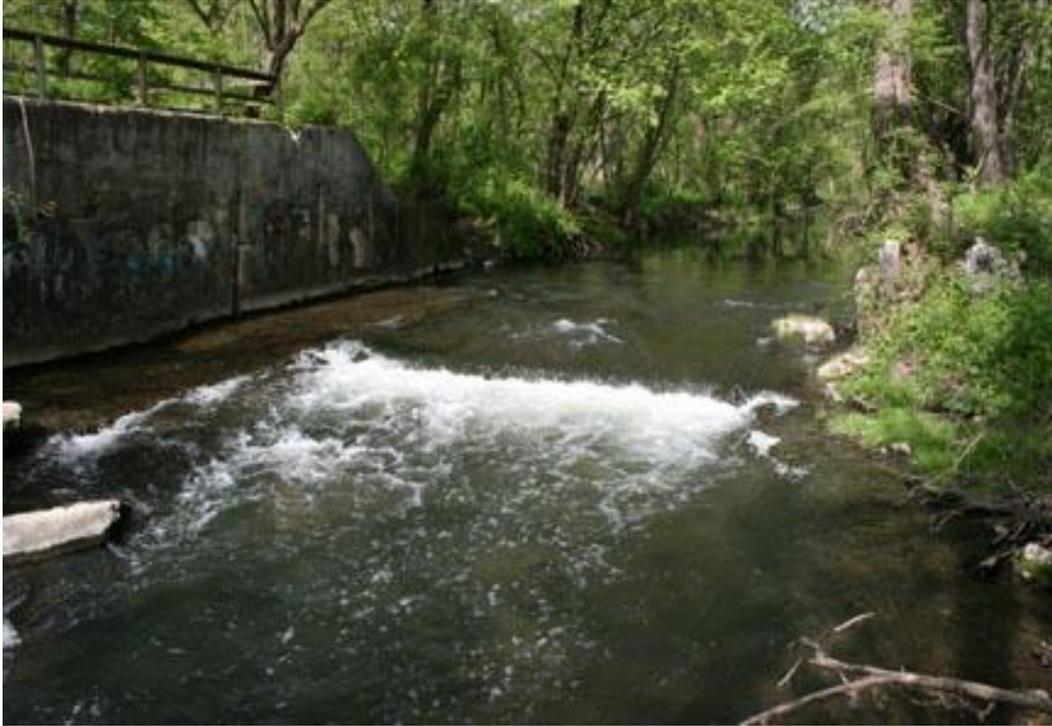
Remnants of an old mill dam located in the upper section of the project area creates a migration barrier to fish under low flow conditions.

- Reconstructing the channel section to provide fish passage by installing boulder step-pools and boulder cascades upstream, through, and downstream of the dam
- Removing the old roadbed and rubble fill
- Grading and stabilizing the banks and floodplain

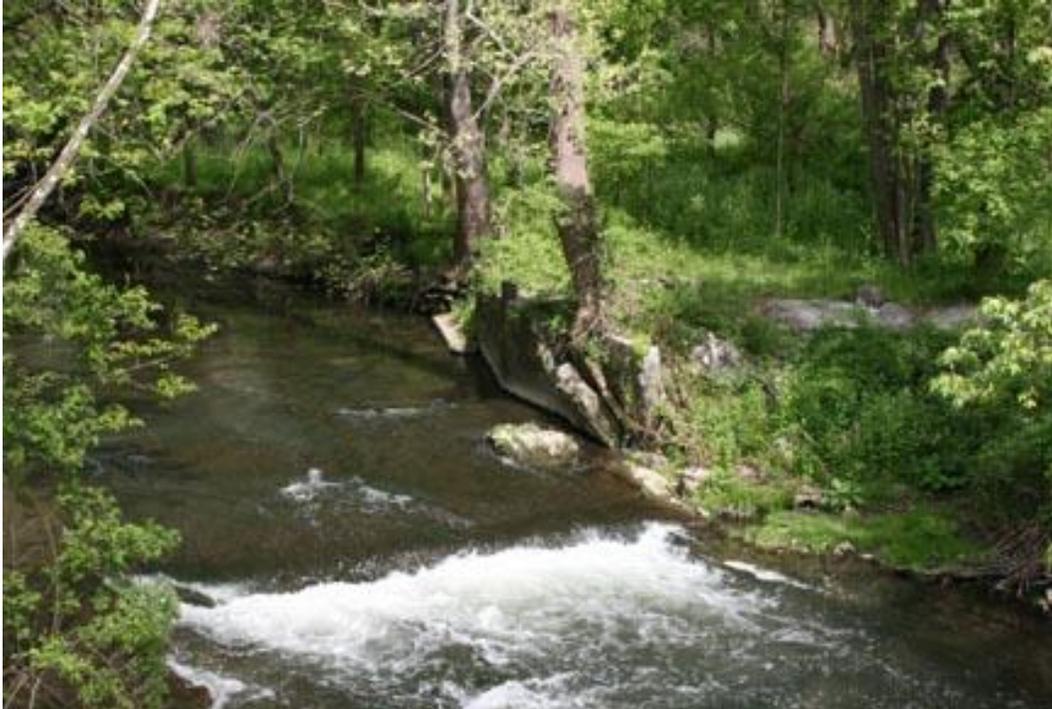
In addition, an old road bed and historic rubble fill have encroached on the floodplain adjacent to the old dam increasing stress on the banks.
