## **Geotechnical Engineering Report for Stormwater Management**

**The Knoll at Iron Valley Additional – REV**

Boyd Street  
Cornwall, Lebanon County, Pennsylvania

ECS Project Number 18:6635-A

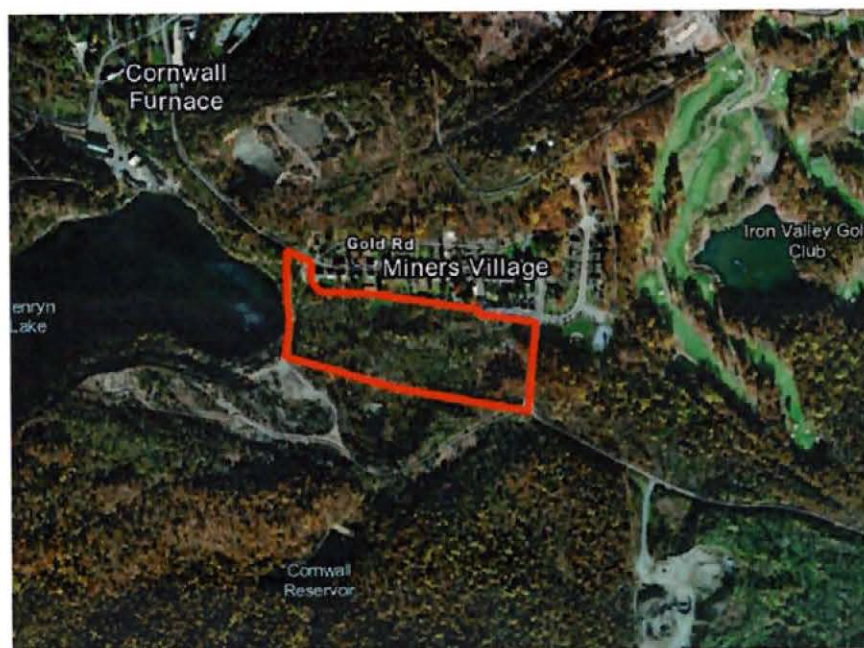
Figure 2.1.A – Site Location

The project site is located west of Boyd Street and south of Granite Street in Cornwall, Lebanon County, Pennsylvania. The property is situated within an undeveloped parcel of land which is predominantly comprised of wooded areas. There is a residential community to the north of the site and a lake to the west of the site location. Based on existing and proposed grades, there is approximately 110 feet of topographic relief across the proposed improvements

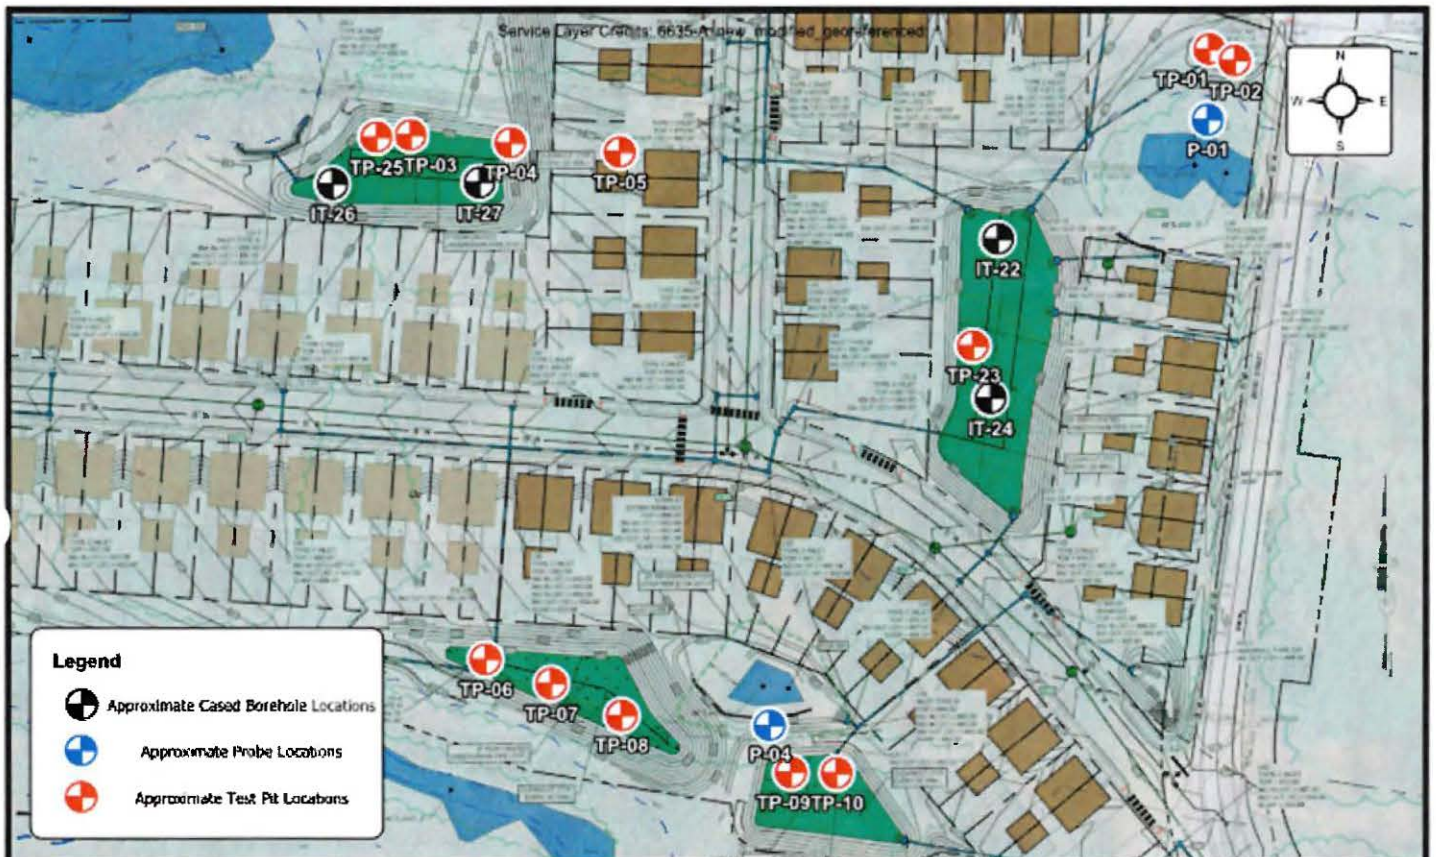
## Exploration Location Diagram

### The Knoll at Iron Valley Additional SWM Testing

ENGINEER  
SJB4  
SCALE  
1" = 100'  
PROJECT NO.  
18-6635-A  
SHEET  
1 of 2  
DATE  
5/28/2026

Our scope of work in July 2025 included excavating twenty-one (21) test pits and performing twenty-one (21) corresponding double ring infiltration tests. Due to site conditions, only nineteen (19) infiltration test were performed. In addition, four (4) test pit probes were also performed. In March 2026 an additional five (5) test pits and five (5) corresponding double rig infiltration test were performed. In addition, five cased borehole probes and infiltration test were performed. Our testing locations were located with a handheld GPS unit and their approximate locations are shown on the Exploration Location Diagram in Appendix A.

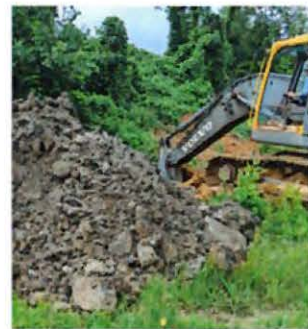
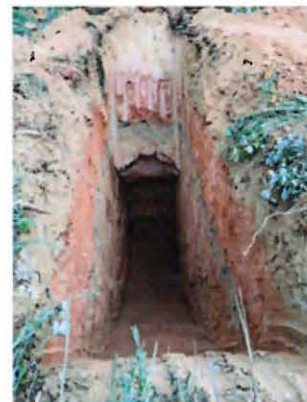
### TEST PIT Procedure:

- Involves excavation subsurface material to observe composition and physical characteristics
- Recording the approximate depth of subsurface strata
- Excavation is continued as prescribed or to limits of equipment and subsurface conditions
- The exploration is typically carried out with an excavator or backhoe, with the depth dependent on machine size and ground

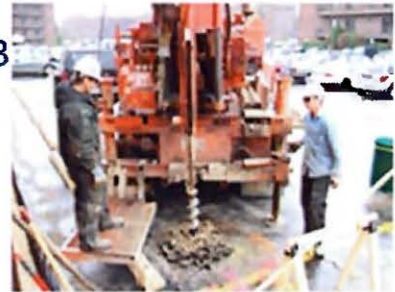
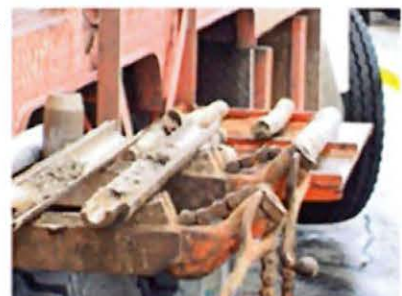
## SUBSURFACE EXPLORATION PROCEDURE: STANDARD PENETRATION TESTING (SPT) ASTM D 1586 Split-Barrel Sampling

- Involves driving a hollow tube (split-spoon) into the ground by dropping a 140-lb hammer a height of 30-inches at desired depth
- Recording the number of hammer blows required to drive split-spoon a distance of 18-24 inches (in 3 or 4 Increments of 6 inches each)
- Auger is advanced\* and an additional SPT is performed
- One SPT typically performed for every two to five feet. An approximate 1.5 inch diameter soil sample is recovered.

*\*Drilling Methods May Vary—* The predominant drilling methods used for SPT are open hole fluid rotary drilling and hollow-stem auger drilling.

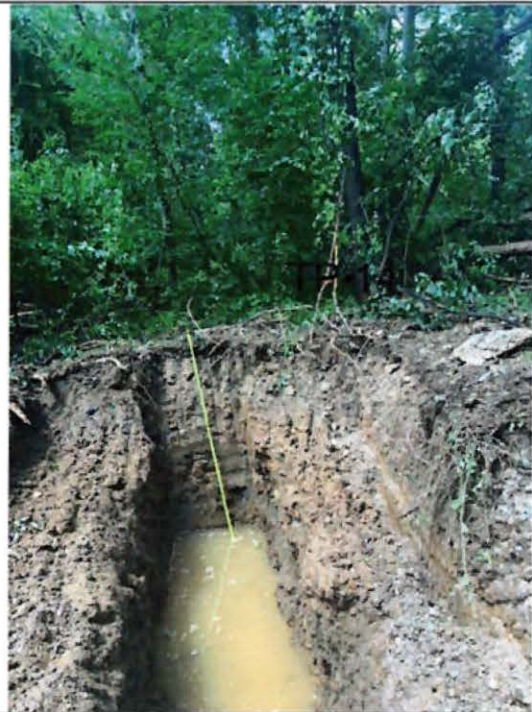
TP-14

- Perched water was encountered in historic fill at approximate elevations of 615.5 - 665.5. Perched conditions were identified at TP-14, 15, 16, 17, and 18. No apparent or visible signs of the seasonal high-water table were observed while probing below the infiltration testing depths.
- Infiltration rates ranged between 0.00 in/hr to 15.41 in/hr, including a factor of safety of 2.0. Due to the variability in our determined rates from the infiltration testing, our rate recommendations will vary based on locations. Please refer to **Section 4.1.1** for specific design rate recommendations.
